Case 10.8 Non-Destructive evaluation of an existing industrial warehouse, Mexico

A Graphite Electrode manufacturing company requested a full structural condition assessment of one of their industrial warehouses in Monterrey, Mexico. After the evaluation, decision would be taken regarding the demolition or repair of the structure. The 50-year-old structure was fully built with cast-in-place reinforced concrete elements. The structure consisted of regular rectangular columns and beams, and a large semi-circular vaulted roof. The longest dimension of the roof from edge to edge was 124 meters. Since the owner of the structure didn't allow coring, a full NDT evaluation program was conducted..

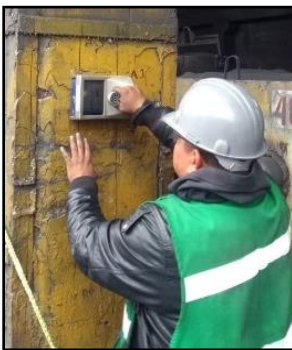
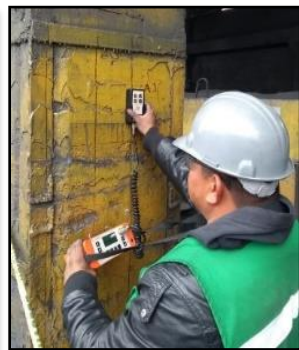
Covermeter for size of bar

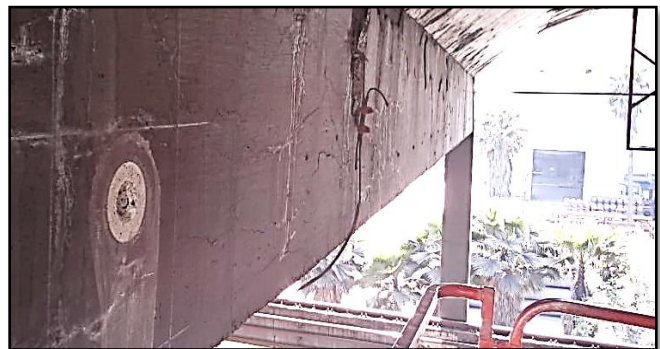
CAPO-test

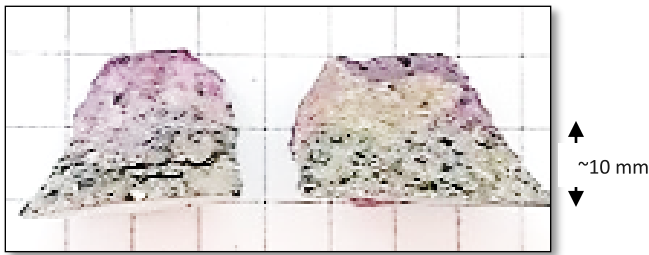
The CAPO test conical pullout cones were tested for carbonation with a pH indicator. It was found that the depth of carbonation on columns was ~10 mm and the beams and roof ranged between 15 to 30 mm. The average coverlayer was 20 mm, the reinforcement of beams and roof was at high risk of corrosion.

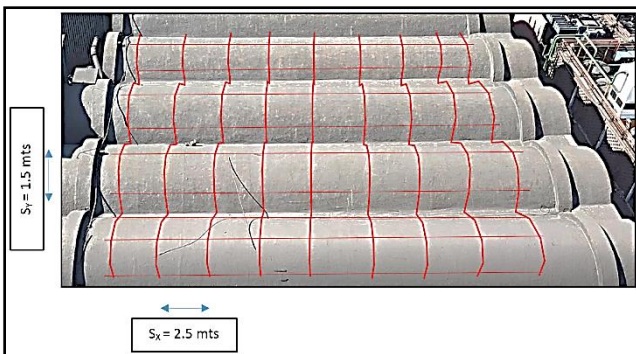
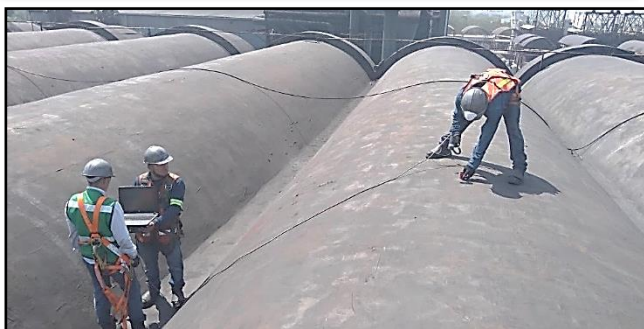
s'MASH Impulse-Response was conducted to quickly evaluate the structural integrity of the large concrete roof. 8,600 m² of roof were tested with around 1,200 points in 1 a full day.

s'MASH Impulse Response on the vaulted roof

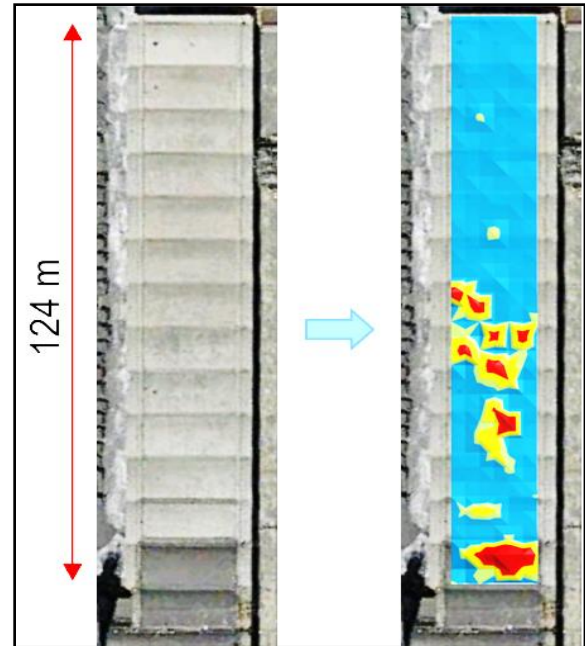
s'MASH contour plot of average mobility

The "average mobility" value of each point was used to compute a statistically modified contour plot as shown with the "sound" areas (blue) vs "unsound" areas (red / yellow). It was found that the areas where high "average mobility" (red / yellow) coincided with heavy corrosion induced damage from carbonation.

Using the calculated equivalent compressive strength as suggested by ACI 228 and the on-site rebar configuration, it was found that the structure was appropriately designed and built. However, after 50 years of service, the structure had developed localized carbonation induced corrosion deterioration on beams and especially the roof, and needed repair. Columns were suffering from mechanical impact due to negligent driving of tractors within the warehouse. A concrete rehabilitation manual was provided to the structure owner.
