Case 10.9. Testing a bridge plate with Impulse Response to determine the extent of ASR induced damage, Sweden

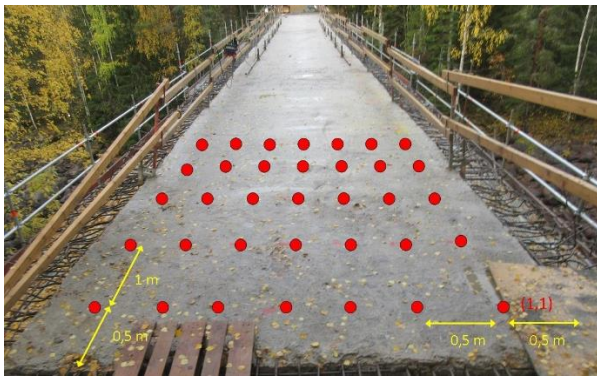
Fig. 1. Photo of bridge from east showing the beginning of the test grid.

Concerns of the condition of the bridge plate led to a request from the owner to make a thorough inspection. Using the Impulse-Response system testing were conducted on the entire bridge plate. The size of the plate is approx. 4 m x 50 m. Measurements were made in a grid with 7 “rows” across the bridge and 49 “columns” along the bridge, approximately 1 m apart. See red markings in Figure 1.

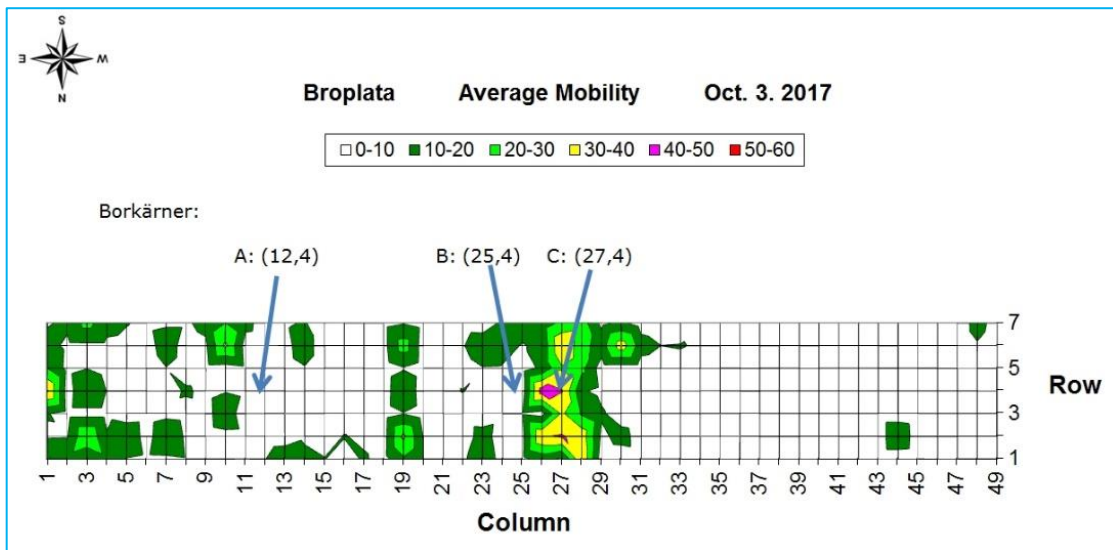
Fig. 2. Average Mobility plot.

- **Core A** sound area
- **Core B** at the edge of area with flaws
- **Core C** from an area with shallow flaws

On the data for Average Mobility (Fig. 2) data shows a delaminated area with shallow flaws in the middle of the bridge indicated by yellow and purple markings. In areas with light green, there is little risk of flaws. The remaining part of the plate is suspected to be in good condition.

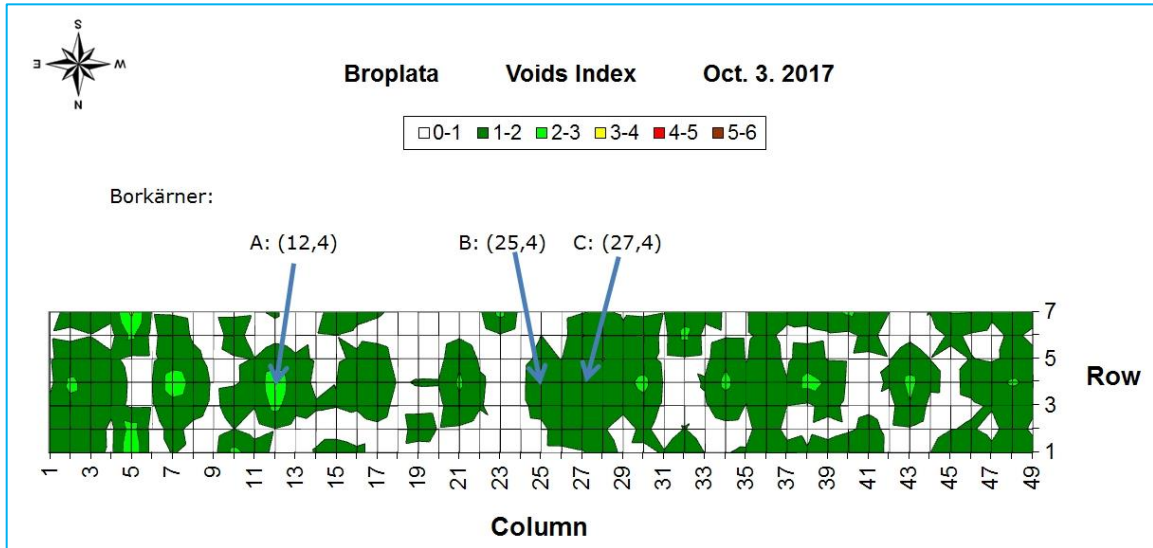
Fig. 3. Voids Index plot.

The data for the Voids Index (Fig. 3) show only a few weak indications of possible deeper minor flaws in the plate. The general conclusion is that there are no deeper flaws.

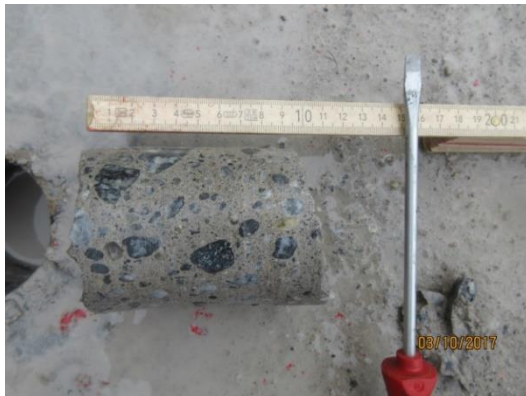
Core A. Intact 100 mm long with few fine cracks.

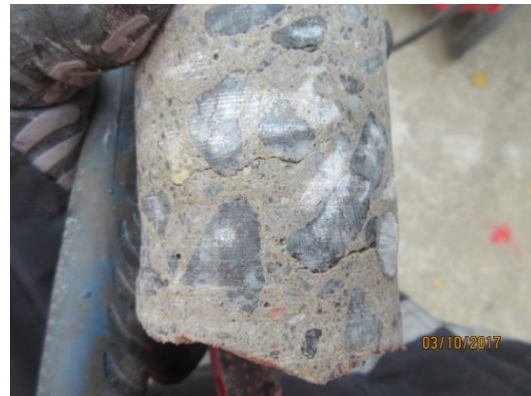
Core B. Intact but with cracks around the aggregates and reinforcement.

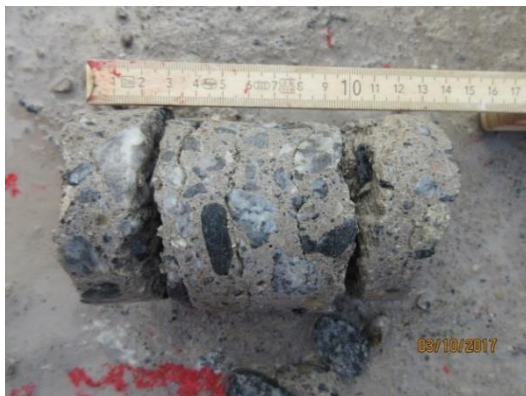
Core C. Delaminated. Typical ASR-cracks.

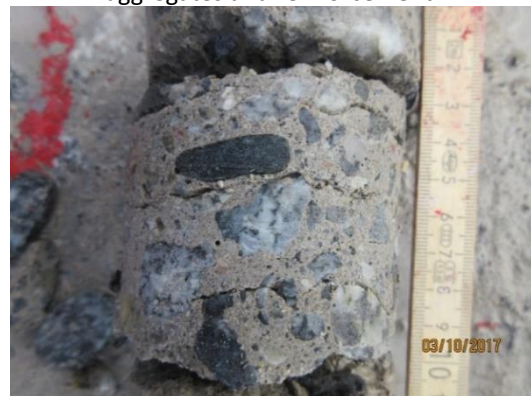
Core C. Delaminated. Typical ASR-cracks
