Case 2.1 Electrical resistance and potentials for corrosion evaluation with the Mini Great Dane

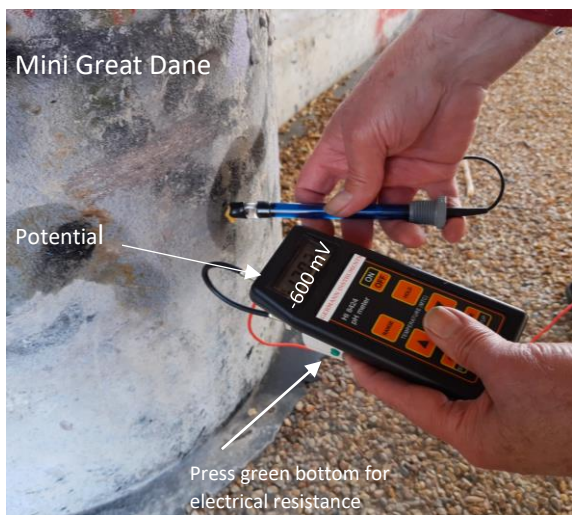
A 5-year old highway bridge column, close to the traffic lane, exhibited a crack (width 0.2 mm) vertically in the column. Suspecting corrosion of the rebars from splash water with chlorides, the following investigation was made.

From 40 cm height and downwards the electrical resistance of the cover layer is low, indicating presence of moist and chlorides.

Chlorides were measured at the footing with **RCT**, showing 0.95% Cl-/mass and further up, at level 60 cm, 0.04 % Cl-/mass.

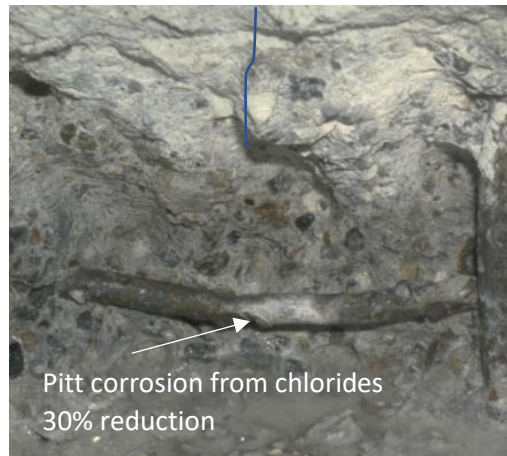
Opening

The potentials are low in the same region with the lowest potentials at the footing, close to the crack -600 mV.

The cover was opened at the location at the lowest potential, -600 mV. The reinforcement was corroded in pits, as illustrated above.
