NDTitans in action

Case 3.1 Water Permeation evaluated by GWT, Germanns Waterpermeability Test

Example 1. Masonry Permeability

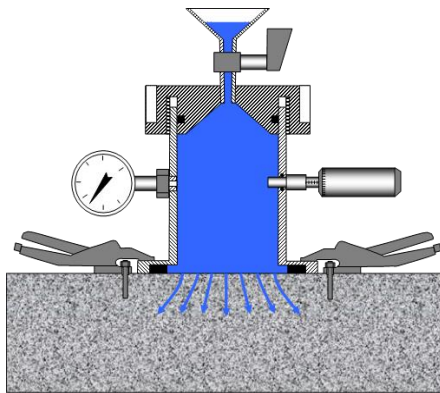
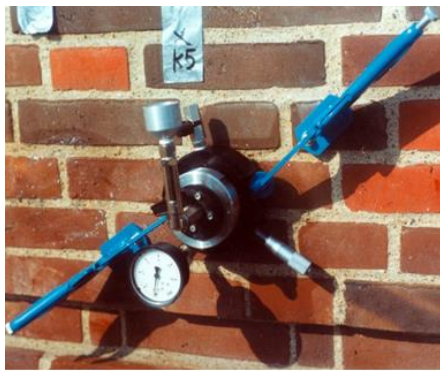
Testing with the GWT was performed as illustrated. The pressurized water penetrated very quickly the walls, in fact it was not even possible to establish any constant water pressure on the surface.

Separate testing was made on the bricks. They were highly permeable. The mortar joints were not the problem. The bricks that had been burned with higher heat than normally, to achieve the "right" color of the bricks, specified by the architect. The increased temperature during production had caused the bricks to become highly permeable.

The walls were applied a "water-proof" invisible sealer and re-tested to make sure rain would not penetrate at high wind

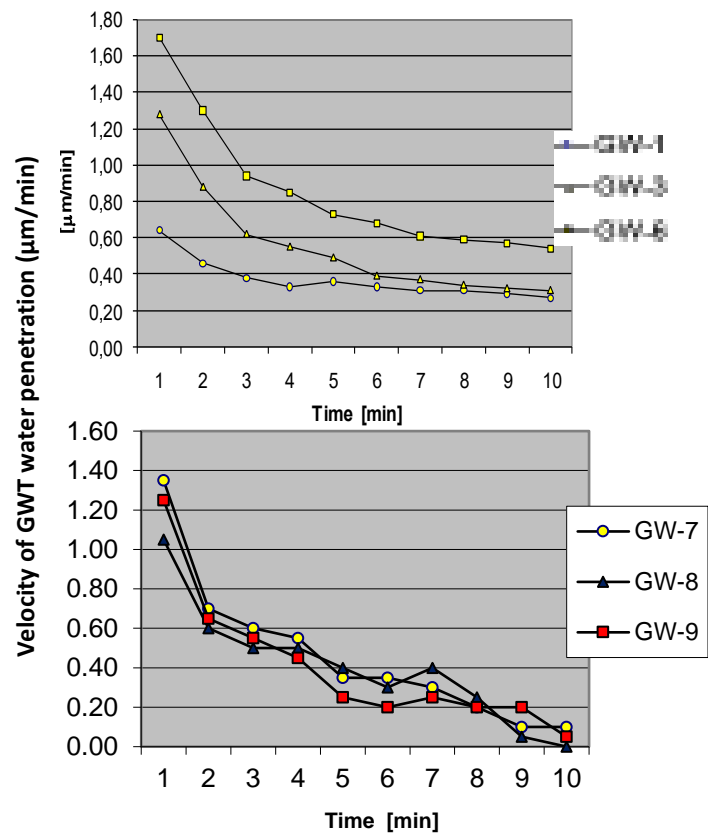
Correlations have been established between the speed of the GWT piston travel and the depth of water penetration using EN 12390-8 "Testing Hardened Concrete, Part 8: Depth of Penetration of Water under Pressure". It has been found that the definition "watertight" concrete of <50 mm penetration depth (EN 12390-8) 72 hours pressure test relates to a GWT water flux of < 0.32 μm/min¹⁾ after 10 minutes.

As will be seen, all sewer pipes passed the watertight requirement Report prepared by **NDTitan Andrzej Moczeko**
