## CASE 4.9 NDT & Strength Evaluation of an Industrial Warehouse, Mexico

A Graphite Electrodes’ manufacturing company requested a full structural condition assessment of one of their industrial warehouses in Monterrey, Mexico. After the evaluation, decision would be taken regarding the demolition or repair of the structure. The 50-year-old structure was fully built with cast-in-place reinforced concrete elements. The structure consisted of regular rectangular columns and beams, and a large semi-circular vaulted roof. The longest dimension of the roof from edge to edge was 124 meters. Since the owner of the structure didn’t allow coring, a full NDT evaluation program was conducted..

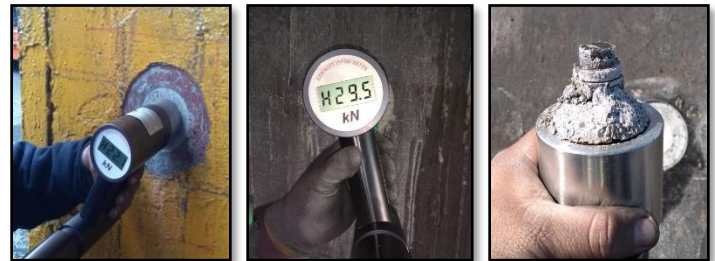
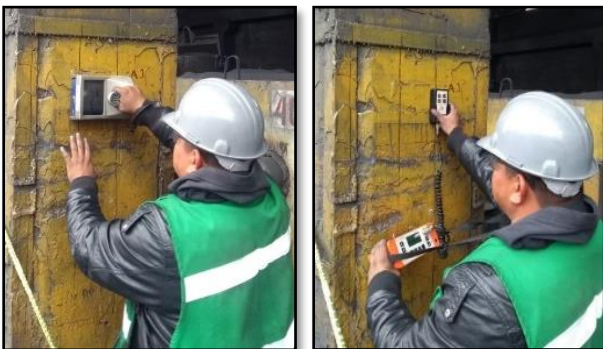
Ground Penetrating Radar with a 2600 MHz antenna was used to scan the structural elements and Cover Meter was used to estimate the rebar diameter. It was found that the average cover layer of all columns and beams was 20 mm.

GPR for rebar depth      Covermeter for size of bar

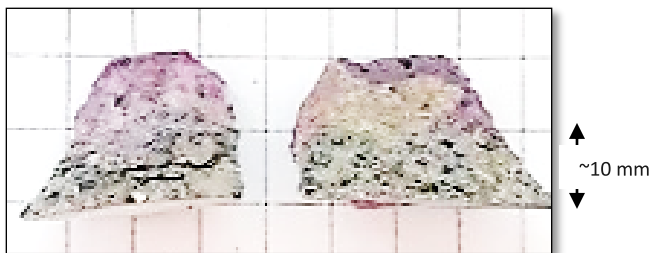
The CAPO test conical pullout cones were tested for carbonation with a pH indicator. It was found that the depth of carbonation on columns was ~10 mm and the beams and roof ranged between 15 to 30 mm. the average coverlayer was 20 mm, the reinforcement of beams and roof was at high risk of corrosion.

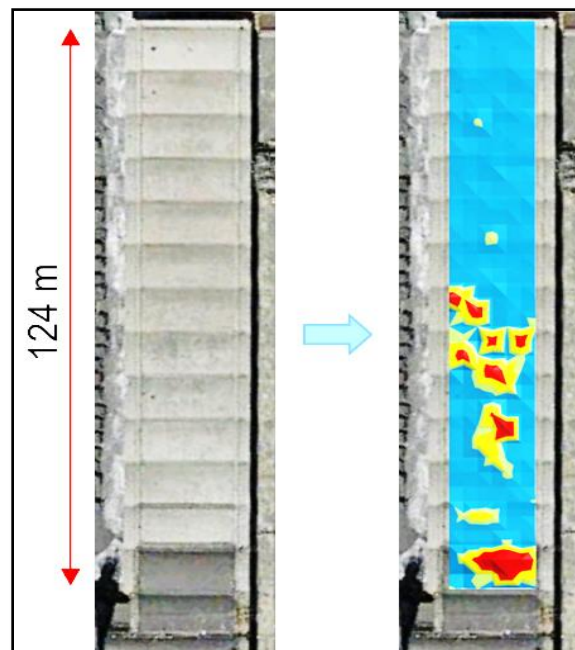
s'MASH contour plot of average mobility

The “average mobility” value of each point was used to compute a statistically modified contour plot as shown with the “sound” areas (blue) vs “unsound” areas (red / yellow) It was found that the areas where high “average mobility” (red / yellow) coincided with heavy corrosion induced damage from carbonation.

Using the calculated equivalent compressive strength as suggested by ACI 228 and the on-site rebar configuration, it was found that the structure was appropriately designed and built. However, after 50 years of service, the structure had developed localized carbonation induced corrosion deterioration on beams and especially the roof, and needed repair. Columns were suffering from mechanical impact due to negligent driving of tractors within the warehouse. A concrete rehabilitation manual was provided to the structure owner.
