Case 5.4 Scrutinizing correlations used for in-situ production control at the Great Belt Link's West Bridge, Denmark

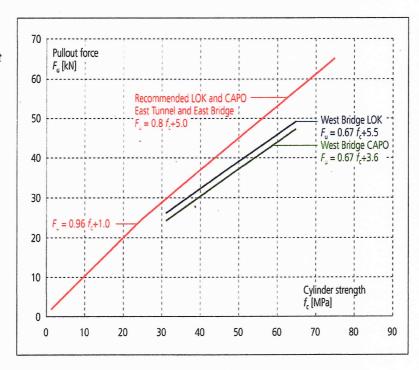
► Fig. 5.3-3 Recommended correlation (red) between LOK-test and CAPO-test pull-out forces and 150mm diameter x 300mm long standard test cylinder compressive strength. This correlation was used for the East Tunnel and East Bridge whereas separate correlation relationships (blue and green) were established for the West Bridge

Note: The red "recommended" correlation reported in 1992, ref.3, p.8, has later been simplified into one general correlation $f_{\rm cyl} = 0.69 \, F_{\rm u}^{1,12}$, relating cylinder strength $f_{\rm cyl}$ in MPa to pullout force, by LOK-test of CAPO-test, in kN pullout force, used from 1992 and onwards, refs. 5, 6 and 7

In this manner the West Bridge correlations shown on the first page was produced, generating approx. 22 % higher MPa strength for a given CAPO-test pullout force.

The reason for the shift in the West Bridge correlation curves compared to the recommended correlation is, beside not adhering to the specified correlation procedure, believed to be caused by lack of proper curing of the concrete blocks for the pullouts.

LOK-test: $F_u = 0.67 f_c + 5.5$ (blue) CAPO-test: $F_u = 0.67 f_c + 3.6$ (green)

Why the difference of approx. 2 kN between the LOK-test pullout forces and the CAPO-test's, LOK-test being the highest?.

Answer: Planning of the surface was not done before testing with the CAPO-test on the blocks. It is imperative to diamond-plan the surface as instructed, to get the correct compressive failure, otherwise a lower pullout force will be produced compared to LOK-test, in this case about 2 kN.

7. The West Bridge correlations are not valid, and should be discharged.
