## Case 6.1 BOND-TEST for evaluating runway joints, Anchorage, Alaska

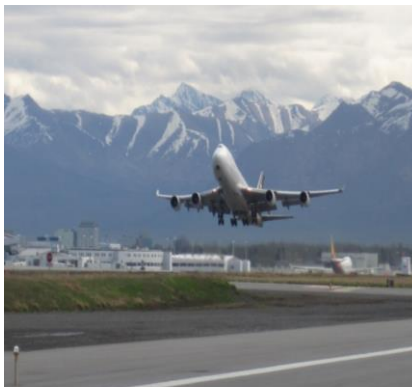
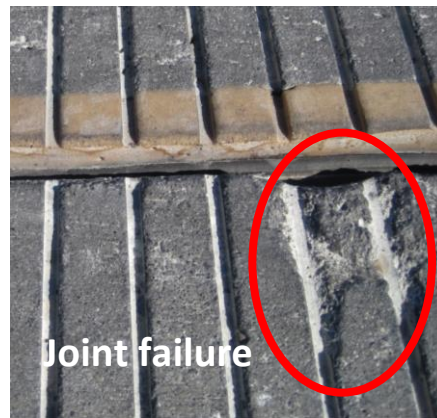
To the discontent of the airlines operating the airport at Anchorage, Alaska, failures in the joints of the runway were observed, loosening pieces of concrete on the surface.

Repair had to be done. BOND-TEST, shown below, was selected for testing the tensile strength of the substrate, and subsequently the adhesion strength between the substrate and the new applied repair material.

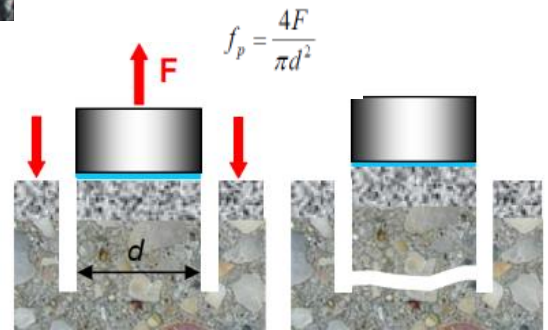
Prior to the repair job, the tensile strength of "sound" concrete was measured,  $f_t = 3.3$  MPa with failure at the bottom of the partially drilled core

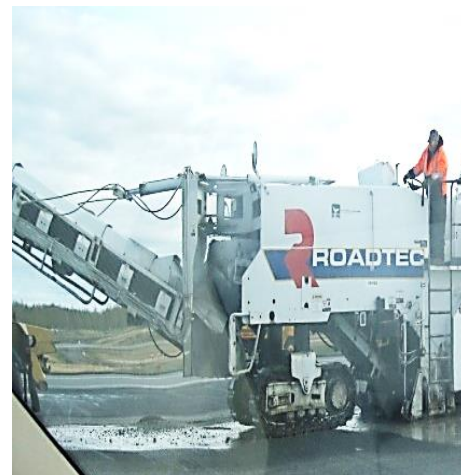
Hydro-jetting

BOND-TEST was used for testing the tensile strength before and after hydrojetting at the bottom of the channel, as well as the adhesion between the water jetted bottom of the channel and the new cast concrete. A significant difference in tensile strength was found in  $f_t$  before hydrojetting, 0.1 MPa to 0.8 MPa, while hydrojetting producing 2.0 MPa to 2.6 MPa tensile strength – the required adhesion strength being 1.7 MPa.

The owner decided together with his consulting engineers to remove existing concrete around the joints in its full length by saw cutting 150 mm on each side, 150 mm deep, chip off the concrete in between to a rather smooth bottom surface and then use hydrojetting of the bottom surface, followed by casting a new concrete material in the channel.
