## Case 7.1. Slab cracking due to improper depth of reinforcement.

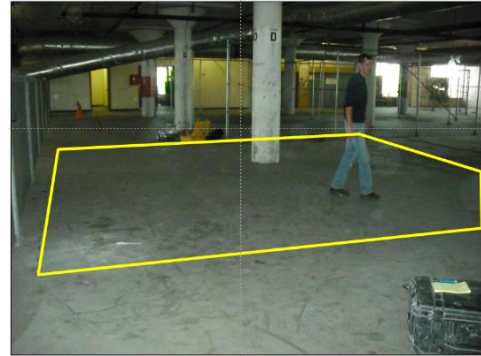
**Fig. 1. Examined slab.**

A 1600 MHz GPR frequency was used, and the area below is 25 feet x 25 feet in size (in yellow) *Fig. 1*:

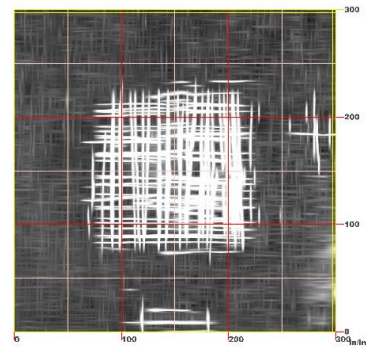
**Fig. 4. Top reinforcement, cracked area.**

*Fig. 4* reveals that the column strip reinforcement was not present at the required shallow depth which would have prevented the cracking as in *Fig 2*.

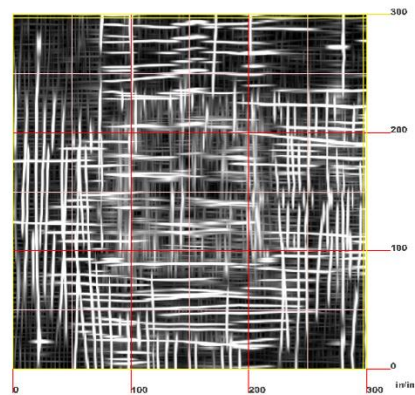
**Fig. 5. Bottom reinforcement, cracked area.**

*Fig. 5* reveals that the column strip reinforcement was present but had dropped lower during concrete placement.
