Case 8.2 Injection quality of old cable ducts with impact-echo, Florida, USA

Fort Lauderdale bridge Florida, USA

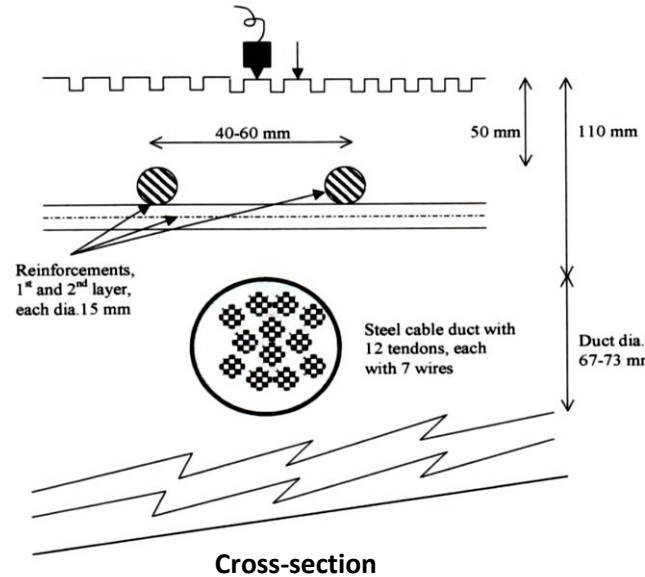
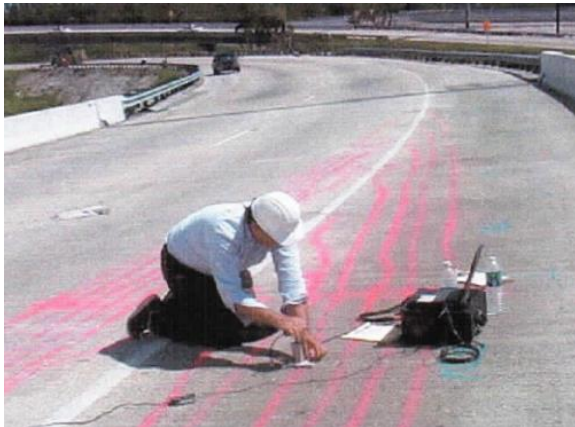
Expected frequencies:

Solid duct: $f = C_p / 4T = 4000 \text{ m/s} / (4 \times 110 \text{ mm}) = 9.1 \text{ kHz}$, by reflection from the steel strands / tendons

Voided duct: $f = C_p / 2T = 4000 \text{ m/s} / (2 \times 110 \text{ mm}) = 18.2 \text{ kHz}$ for an assumed $C_p = 4000 \text{ m/s}$ and a 110 mm depth to the duct, The actual frequencies found are illustrated below.

Types of signals found:

- SOLID**
- VOIDED**
- Partially VOIDED**

The actual P-wave speed could be back-calculated from $C_p = 2 \times T \times f = 2 \times 122 \text{ mm} \times 17.33 \text{ kHz} = 4228 \text{ m/s}$, using the $f = 17.33 \text{ kHz}$ found for the voided duct, if needed

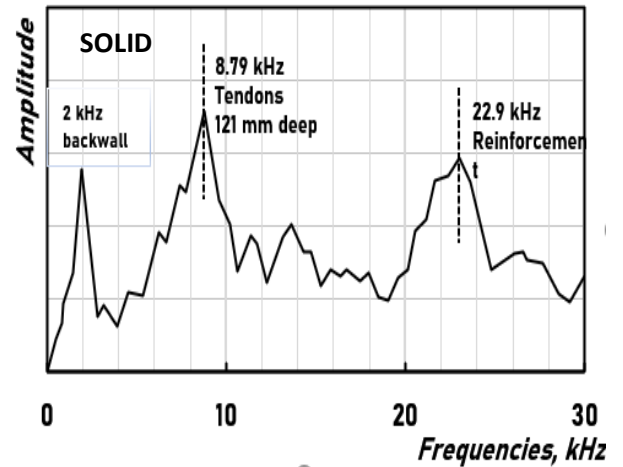
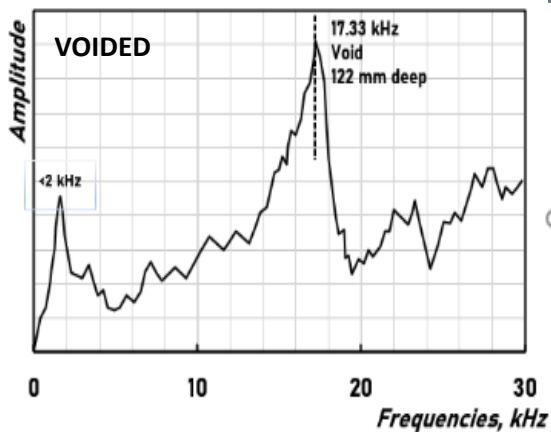
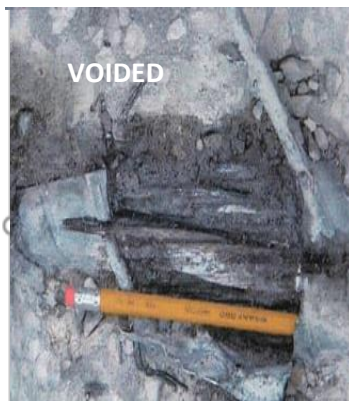
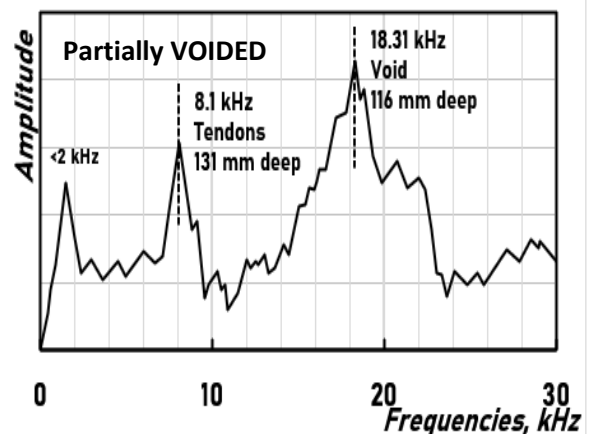
1,200 impact-echo tests were made with 20 cm distance in between, on 6 randomly selected ducts. Two ducts were found to be fully injected, while the four others had voids at non-systematic locations, usually 1-2 m in length. Opening of the voided ducts confirmed the testing results. Interesting enough, water under pressure was present in the openings, and the strands / tendons were only slightly corroded as illustrated.
