Case 8.3 Duct inspection of a three-span bridge in the West of Ireland with the DOCTer

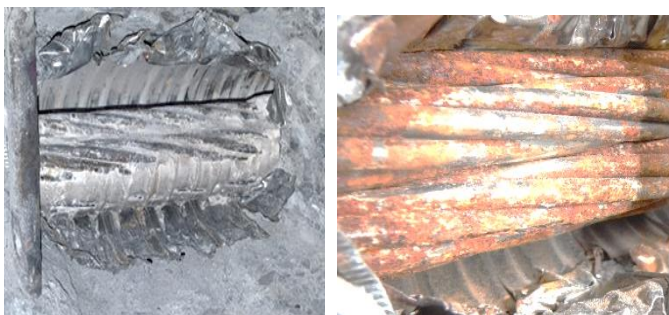
During the Special Inspection, post-tensioning ducts were located using GPR and a couple of exposures were made to the ducts and tendons. In two of the four ducts opened, fully voided ducts with corroded tendons were found. There was no evidence of water ponding within the ducts.

Left, injected duct. The right figure show a voided duct with corroding tendons in the down stand beam of the bridge. Corrosion was visible but no severe pitting evident

The main cause of structural concern was that a number of tendons were found to be loose (the Infrastruct team were able to easily move the tendons with hand tools and little effort). This indicated to the team on site that the tendons were not stressed as would be expected for post tensioned strands.

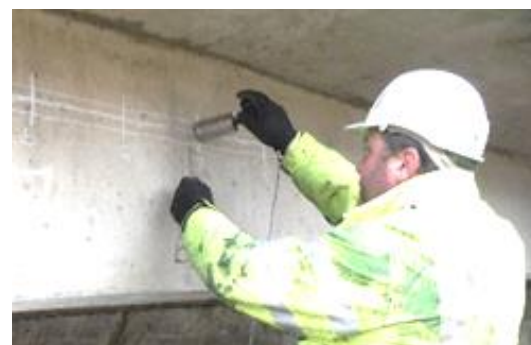
Impact Echo testing using the DOCTer Impact Echo system underway to determine the ducts condition

2000 Impact Echo tests were completed. 50% of the ducts were partially voided, 4% of the ducts were fully voided and only 46% of the ducts were found to be fully grouted.

The bridge was replaced after the findings of the PTSI.
