Case 9.1 Injection quality of existing cable ducts tested by ultrasound tomography and impact-echo, Finland

Evaluation of prestressing duct's condition (Ramboll Finland Oy) at various locations along the bridge, mostly at the anchoring zones and mid spans was performed by using the MIRA ultrasound tomography and Impact-Echo on the Leiviö over bridge in Finland for the Finnish Road Administration. The bridge constructed in 1971 is a continuous prestressed concrete box girder bridge 102 m long.

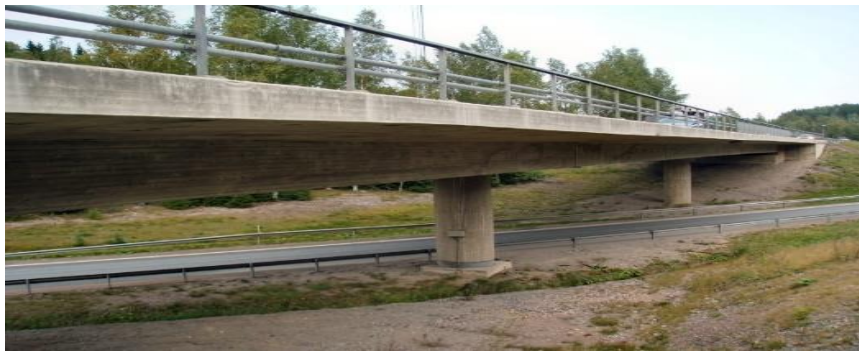
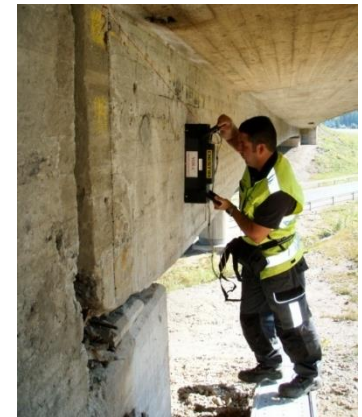
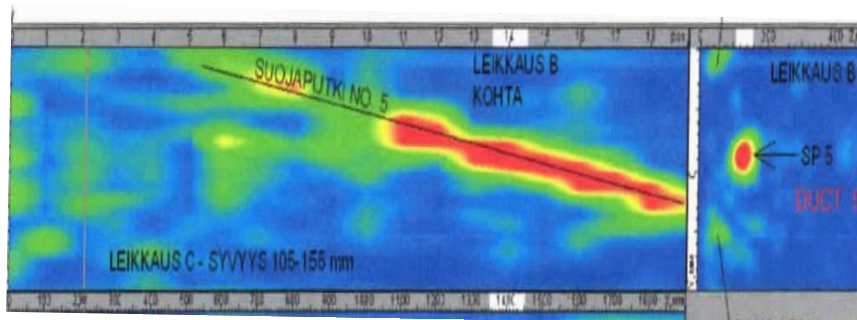
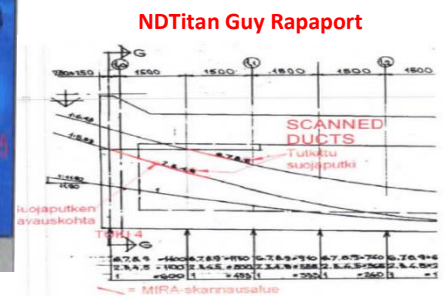
At several investigation zones intensive and continuous reflections were detected at the locations and depths of the ducts (red color). Accordingly, similar findings were made with Impact Echo investigations (dominant peaks at depth of ducts). At one location it was decided to open the suspicious duct at a distance of one meter from the head of the anchor holding the strands, carried out by coring to the corrugated tube, which was opened as well. The findings are illustrated below.

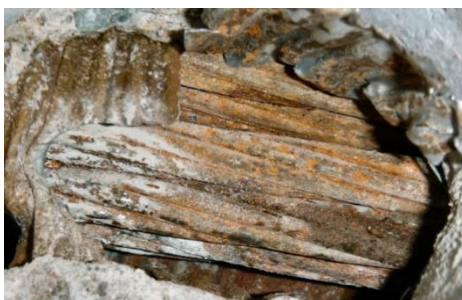
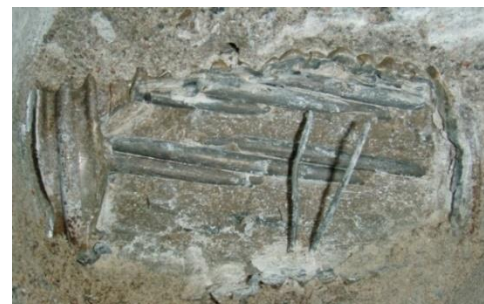
The duct was empty of injection grout and the strands were severely corroded, yet only mildly pitted. In comparison, in another area, where the MIRA did not show intensive reflections (red color), but only slightly green/yellow color (non-suspicious), another similar opening was made. As seen, the strands were fully encapsulated by injection grout, well protected. The strands are in good condition with no signs of corrosion. The case shows how important it is to evaluate the injection of the ducts during and after completion, e.g. with MIRA and DOCTer Impact-Echo, including verification of the results by invasive means.
