Examples of collapses / damages involving insufficient / changed strength in-place and insufficient quality of the cover layer

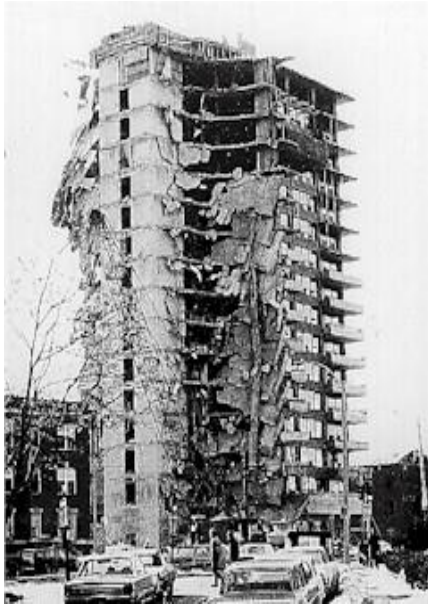
Collapse during formwork removal ,
Boston, USA.
6 fatalities
Standard cylinders tested had passed the
requirement.
Subsequent investigation showed the in-
place strength to be 50% of the cylinder
strength at the time of formwork
removal.

LOK-TEST used hereafter for timing of
safe and early loading.

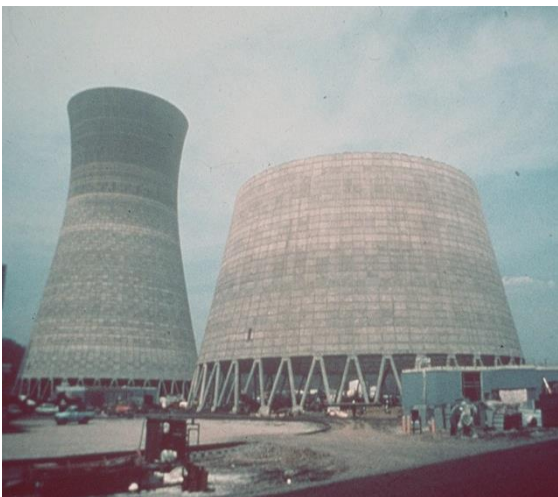
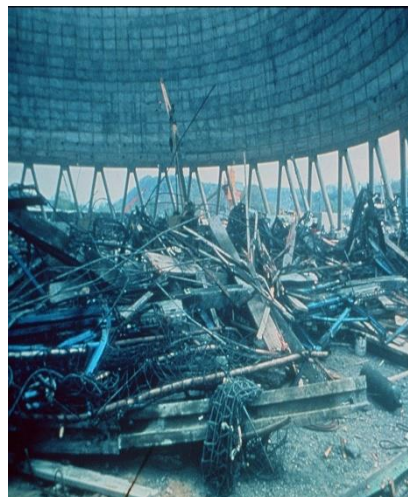
Cooling tower collapse

Failure due to insufficient
strength to support the next “lift”,
West Virginia, USA
51 fatalities
Timing of next lift was
determined by cylinders.

LOK-TEST in each lift was
subsequently used for timing of
lifting the form

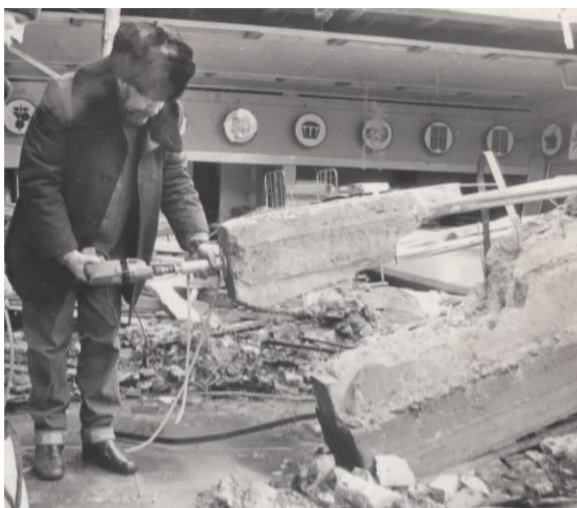
Collapse of beams

Beams collapsed in a grocery
store, Moscow, Russia
7 fatalities
Lab cylinders had passed the
required strength of $f_c = 40$ MPa
Capo-Test showed 9 MPa
strength in-place after the
collapse.

Capo-Test being shown in
progress.

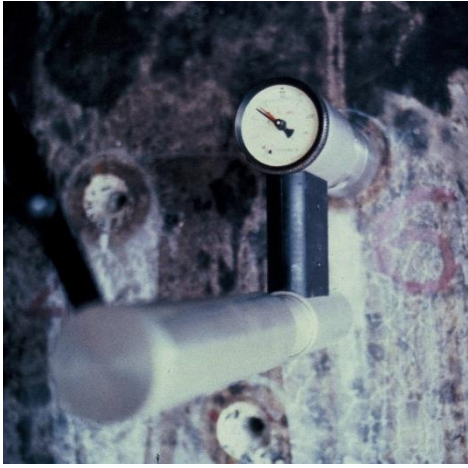
Fire damaged structure

Walls in a fire damaged apartment building, Denmark
Testing with CAPO-TEST being shown.

Cylinder strength $f_c = 40$ MPa, documented by the factory
CAPO-TEST showed 18 MPa, 17 MPa and 16 MPa for the three tests illustrated, averaging 16 MPa, indicating a 60% reduction in the strength caused by the fire.

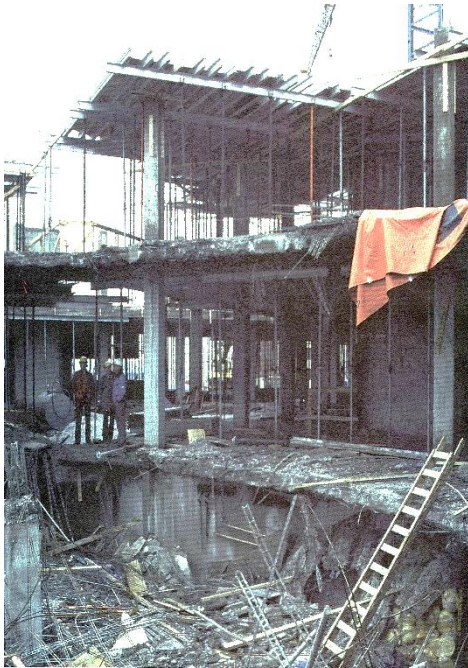
Collapse of slabs

Slabs collapsed during construction in the wintertime of a hospital building, north part of Sweden.

Form and supports removed 10 days after casting. No strength records available at the time of loading.

Capo-Test showed 3-5 MPa cube strength in-place and traces of ice-flowers in the concrete.

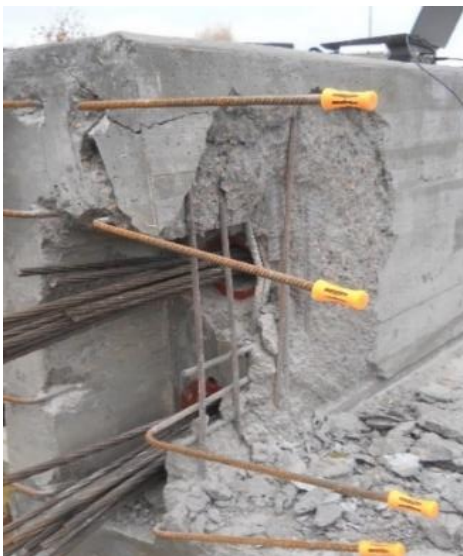
Collapse during tensioning

Bridge girder tensioning collapse in the trumpet zone, Denmark.

Time of tensioning decided upon by pre-established strength-maturity relation.

Actual in-place strength could have been established prior to tensioning by using pullout.

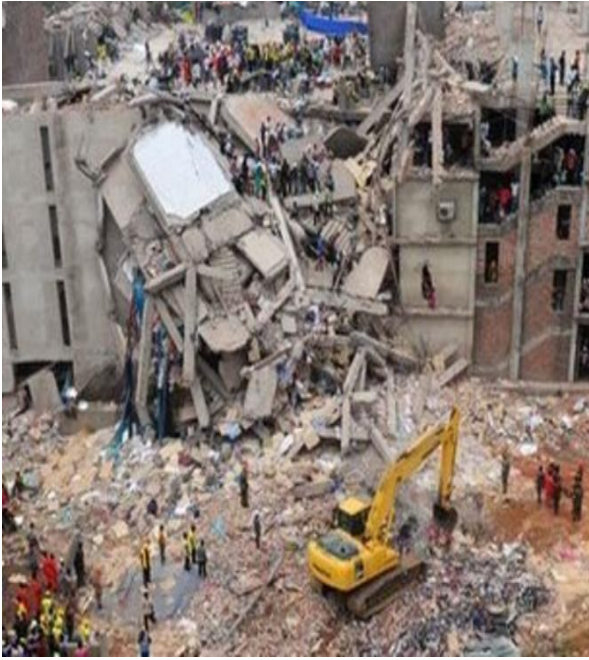
Textile factory collapse

RANA PLAZA COLLAPSE, Dhaka, Bangladesh

Another 3 stories were built on top of the existing factory. Cracking in the walls happened during activating electrical generators on top of the building.

Strength testing of the concrete quality months before the collapse was made by rebound hammer, UPV and cores.

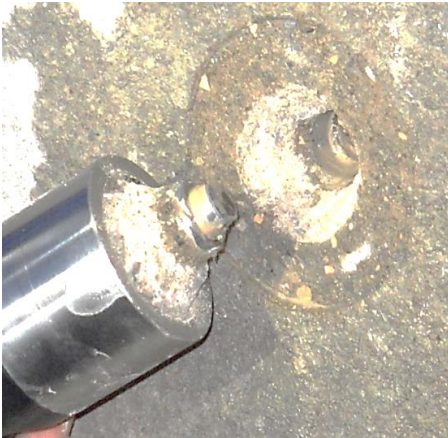
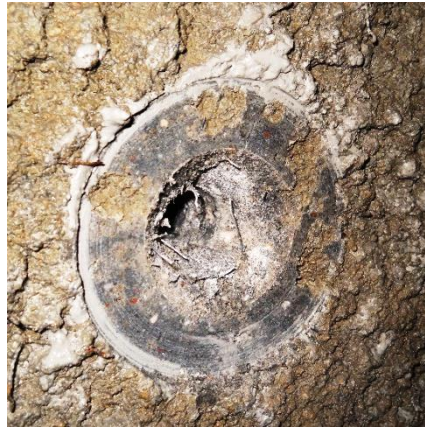
Shotcrete lining collapse.

Canadian uranium mine shotcrete lining had collapsed due to low strength and flooded the mine. On trials CAPO-TEST was applied to ensure a minimum 30 MPa strength in-situ. Photos from CAPO-TEST testing of wet-sprayed shotcrete without fibers (32 MPa) and with steel fibers (48 MPa)

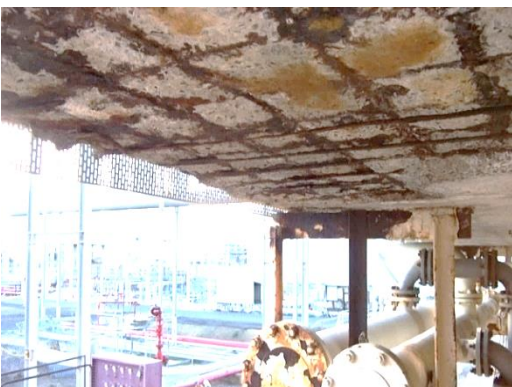
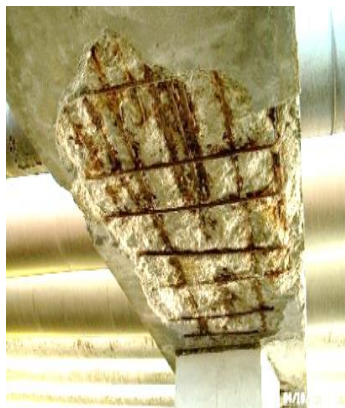
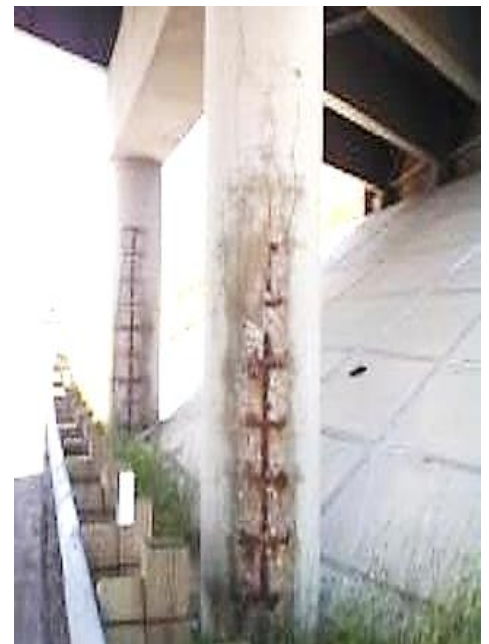
Non-durable, permeable cover layers

Examples of insufficient quality of cover layers causing reinforcement corrosion after 10-15 years of chloride exposure. Examples are from Dubai, from India and from USA. Testing for durability at the time of construction could have been done by CAPO-TEST, not at least to check the curing applied, if any

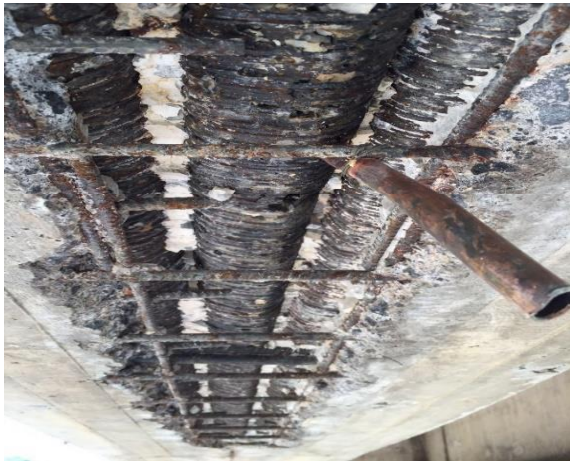
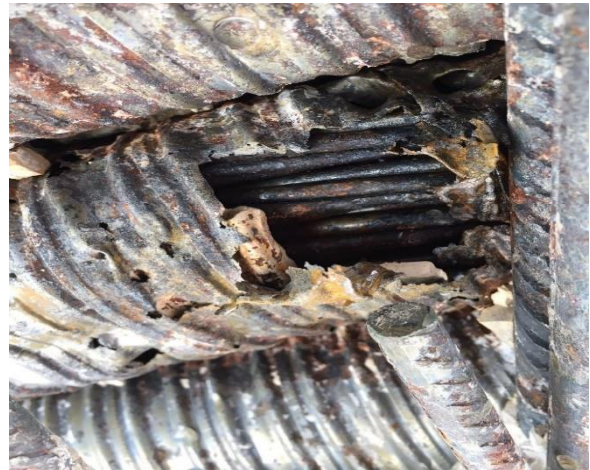
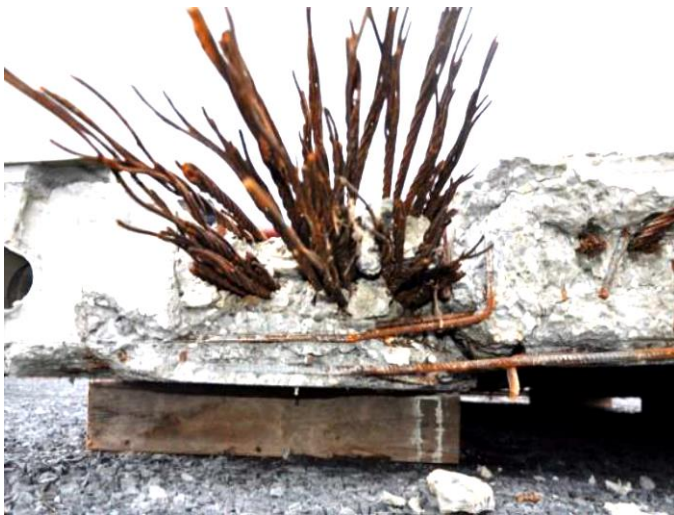
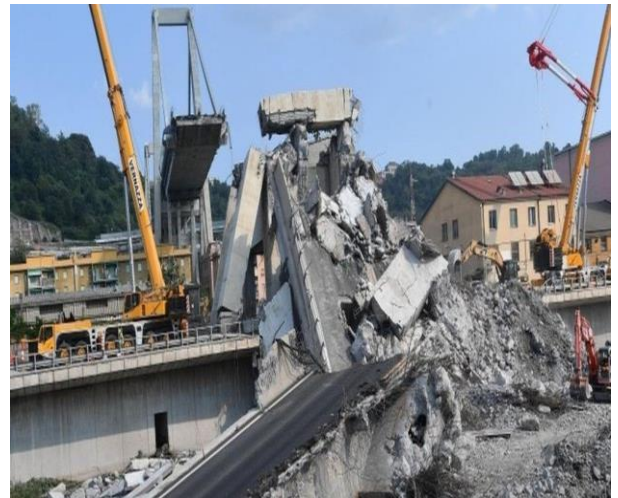
Tendon collapse in cable ducts caused by chlorides / moist / oxygen penetrating non-durable cover layers and construction joints.

Examples are from Italy, from ribbon bridge collapse in the Czech Republic and from Italy, the Genoa Morandi bridge collapse (42 fatalities)

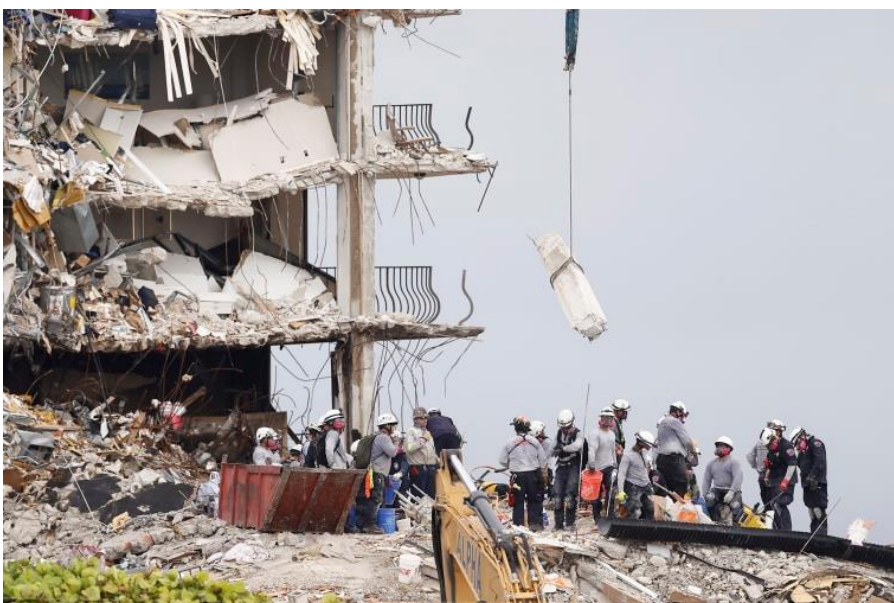
Surfside condominium collapse, Miami, USA

Collaps caused by several factors including long-term degradation of reinforced concrete structural support in the basement-level parking garage under the pool deck, due to water penetration and corrosion of the reinforcing steel from chlorides penetrating the cover layer
