## **NDTitans in action**

## Case 2.3 Carbonation depth with Rainbow Indicator and Deep Purple, Poland

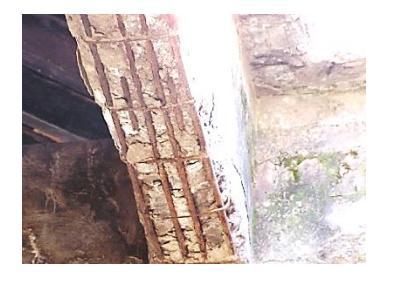
Severe cases of carbonation damage

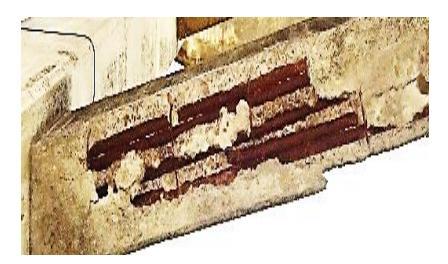
Incl. "pitting" from Cl<sup>-</sup>

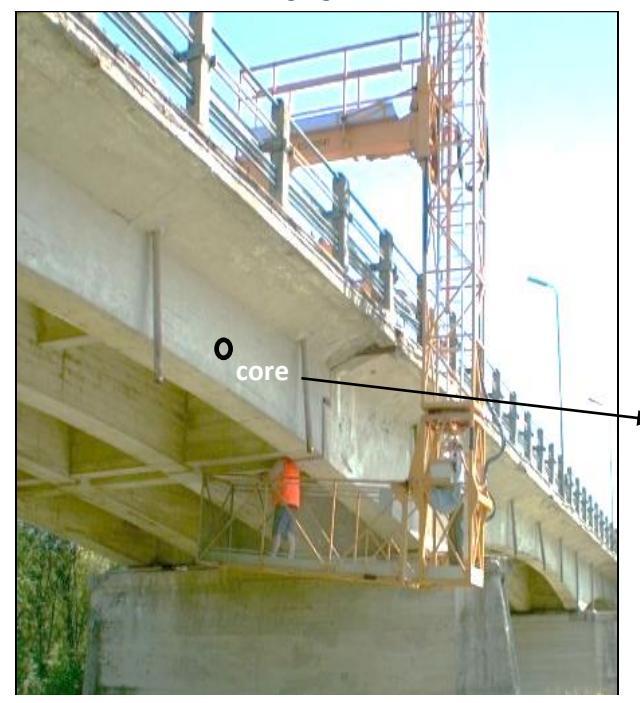
**Rainbow Indicator** and **Deep Purple** for depth of carbonation on a bridge girder

As part of bridge investigations in Poland the depth of carbonation was tested, both with the Rainbow Indicator and the Deep Purple indicator used, sprayed on freshly cut cores.

The Deep Purple and the Rainbow Indicator produced the same depth of carbonation, from the inside of the girder 54 mm and from the outside 25 mm. The reason for the different depth is that the outside is subjected to rain, slowing down the carbonation process, while the inside is relative dry.

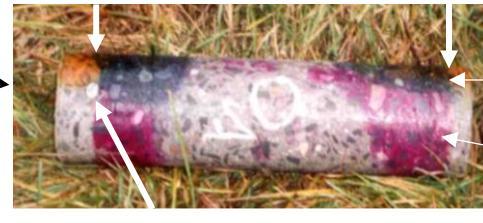
Carb. depth 54 mm Inside of Girder Carb. dept 25 mm Outside of Girder

Reinforcement 40 mm deep

With the depth of the reinforcement 40 mm, misleading information concerning the protectiveness of the reinforcement could be given if testing was only made from the outside of the girder.

The reinforcement positioned at the inside of the girder had in fact started corroding, while reinforcement at the outside had no signs of corrosion.
