# NDTitans in action

## Case 10.2 Integrity of North Virginia's Interstate 66 bridge deck evaluated by impulse response, USA

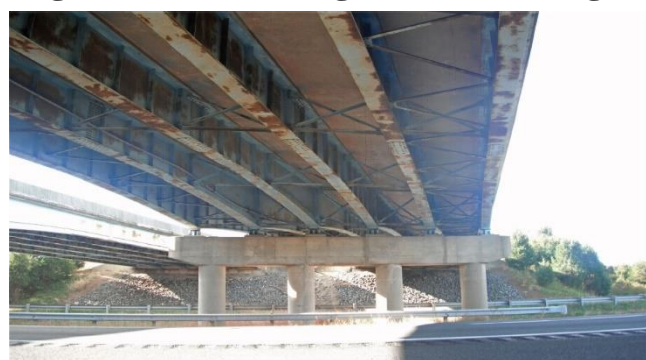
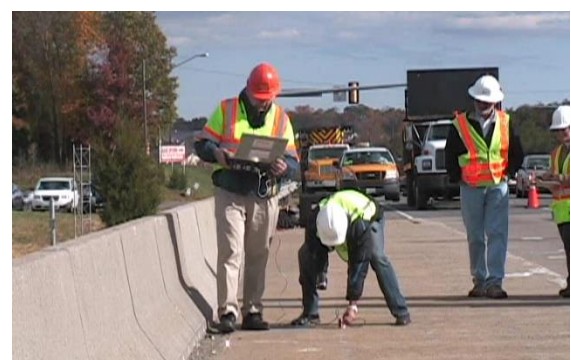
MOBILITY

Delamination

Honeycomb

The suspicious areas found were subsequently tested by DOCTer Impact-Echo, by which the presence of the delaminations and the honeycomb were established. Testing of the whole slab lasted 2.5 hours.
