NDTitans in action

Case 10.6 Quality Assurance of newly repaired bridge deck, Finland

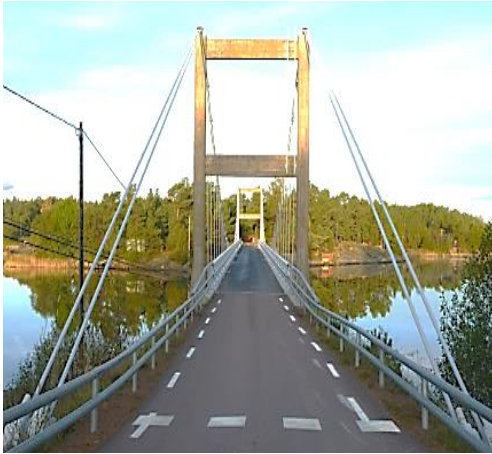
Cross-section of the bridge. Deck: 50 mm asphalt on 250 mm concrete slab with waterproofing layer in between, area 350 m²
Arrows indicate the s'MASH test points across

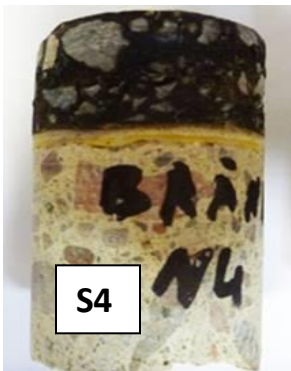
Validation points S4 and S3

- S4 (green area) bonded waterproofing, BOND-Strength $f_t=1.0$ MPa (req. ≥ 1.0 MPa)
- S3 (red area) waterproofing debonded.

Conclusion & Recommendation: Renewed repair in the red areas, followed up by re-testing.
