**Case 14.1 Petrography, examples of micro- and macro analysis**

**Petrography**

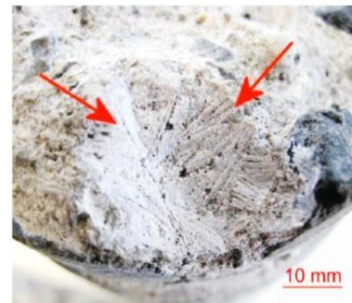
2. Ice flowers formed between aggregates and cement paste before hardening of the concrete (sign of early frost exposure).

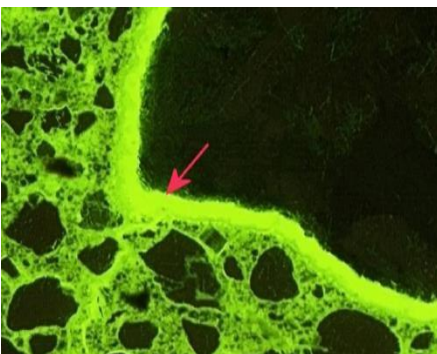
5. Thin section, 1 mm x 1.5 mm, from concrete suffering from DEF, Delayed Ettringite Formation. Severe internal expansion may occur if the concrete had high temperature at casting/early curing. This can happen years after casting when moisture becomes available.
