Case 4.8 NDT & strength evaluation of overhead water tanks, Punjab, India

Avantech Engineering of India, was assigned the task of investigating the health of concrete and reinforcement in four water tanks constructed, using Non Destructive and partially destructive test methods.

The objective of the investigations was to assess the in-situ concrete compressive strength, concrete homogeneity, surface hardness, corrosion risk, concrete cover and depth of carbonation using Non-Destructive and minimally destructive techniques to diagnose the type and cause of distress in the structures.

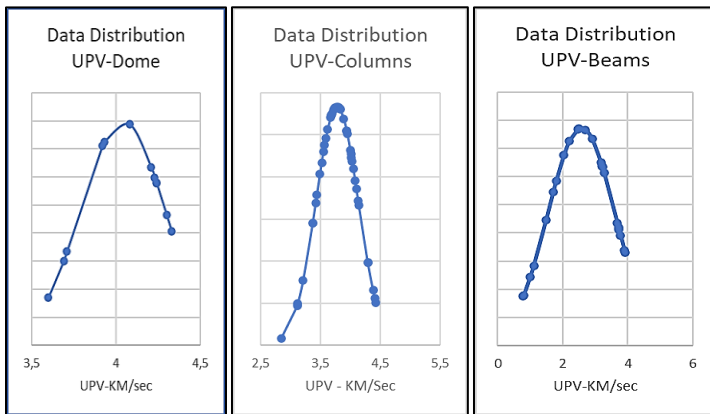
UPV (Ultrasound Pulse Velocity) tests were carried out to assess the general quality and homogeneity of concrete.

Aver: **4.0**
km/s Dome

3.8
Columns

2.4
Beams

Evaluated by UPV the quality of domes and columns was generally good and uniform with all UPV values above 3.5 km/sec. The beams exhibited the worst quality with about 74% readings below 3.5 km/s and average UPV only 2.4 km/s

1. The in-situ strength of concrete in beams was observed to be considerably lower than concrete strength in domes and columns. This may be corroborated with original design data and suitable structural design checks. .
2. Concrete homogeneity in domes and columns was adequate, however, the concrete quality and homogeneity in beams was found to be poor.
3. There is a significant risk of active corrosion in rebars in all tanks. The carbonation depths are quite significant, exceeding the cover depth in most cases and therefore appear to be the main cause of active corrosion. Poor homogeneity of concrete and lower cover depths as observed in beams increase the porosity and therefore the risk of higher active corrosion.
4. The customer was advised to take adequate remedial measures to arrest the active corrosion and draw a plan for repair/ rehabilitation of the water tanks.

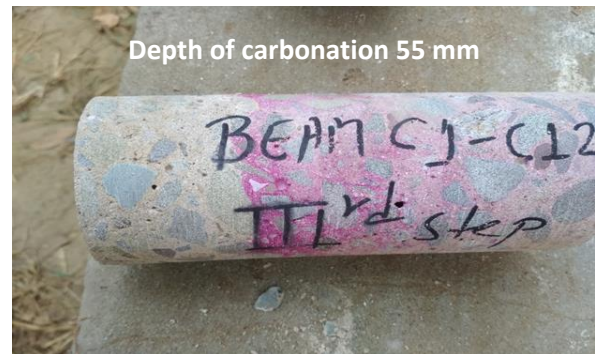
The lowest cover was on the beams (22 -27 mm), on the domes (45-67 mm) and on the columns (43-57 mm)

In almost all cases the depth of carbonation was larger than the depth of the reinforcement, causing loss of protection from the concrete's alkalinity, and making the rebars corrode.
