Case 5.3 Production control of the cover layer at The Great Belt Link project, Denmark

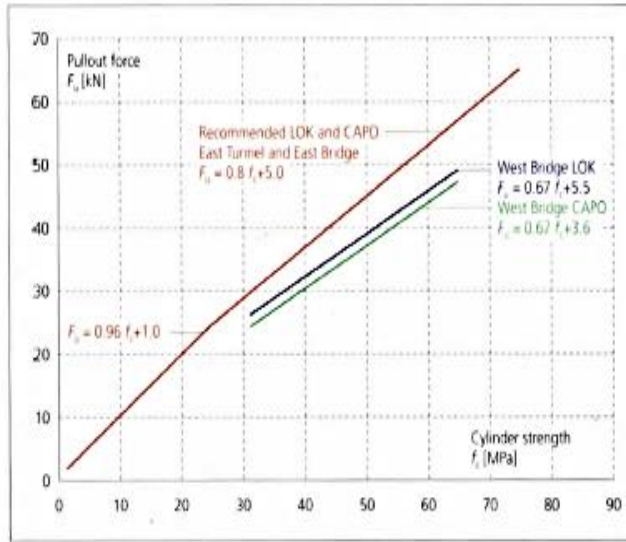
► Fig. 5.3-3 Recommended correlation (red) between LOK-test and CAPO-test pull-out forces and 150mm diameter x 300mm long standard test cylinder compressive strength. This correlation was used for the East Tunnel and East Bridge whereas separate correlation relationships (blue and green) were established for the West Bridge

The general correlation shown in the next page, recommended by Germann Instruments and based on data from international research and construction projects, was used for the East tunnel and East bridge as it matched reasonable well with the actual correlations obtained (dotted lines). However, during full-scale trial castings for the West Bridge, it was realized that the in-situ CAPO strengths determined by the general correlation were significantly lower than the LOK strengths. The obtained values also indicated a potential risk of rejections, so it was decided to carry out a correlation test for the actual West Bridge concrete. For this purpose, several 400 x 200 x 200 mm blocks were prepared with four LOK-test inserts (air curing outside the lab) After each 4, 7, 28 and 56 maturity days, six blocks were tested with LOK and CAPO along with 18 lab cylinders for standard strength tests. The West Bridge correlations found and used for the project are shown with the blue and green solid lines.

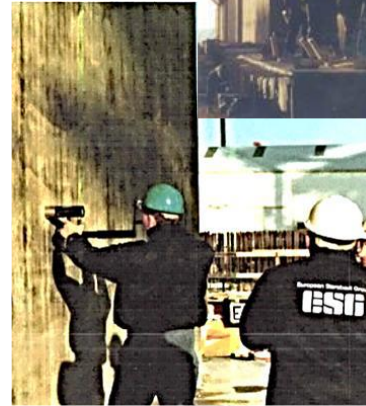
CAPO-test on the caissons of the West Bridge

In-situ strength testing had never before been used for production tests in Denmark, but on the Great Belt Link LOK-test inserts were used for all structures (in average 1 test for every 25 m³) except the slip-formed caisson walls (West Bridge) and the tunnel lining segments, where CAPO-test rings were inserted at the time of testing.

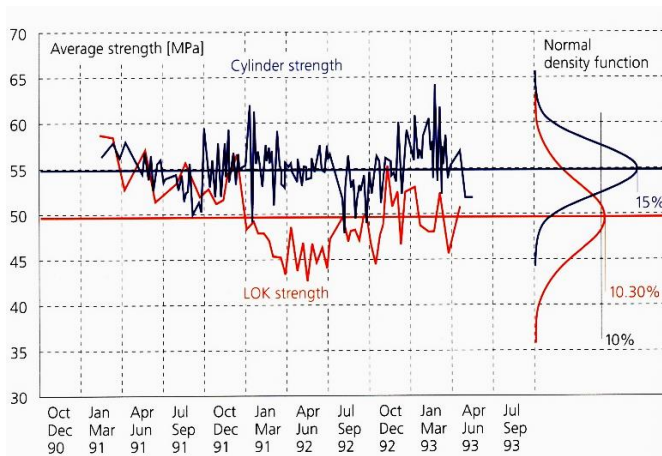
As an example of production testing, the West Bridge rail girder inspection sections were tested by LOK-test inserts. In the beginning, the cylinder and in-situ strengths were almost identical until November 1991. From then on, the LOK-strength was about 10% lower because of poorer concrete, but the concrete cover complied with the requirements if the characteristic 28-day's LOK-strength was above 36 MPa.
