NDTitans in action

Case 8.1 Injection quality of new cable ducts with DOcter

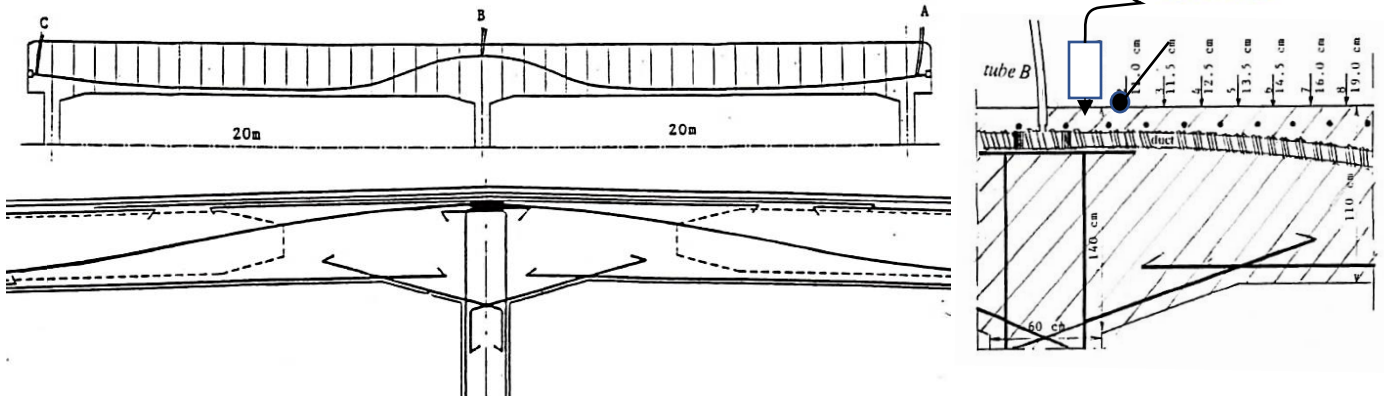
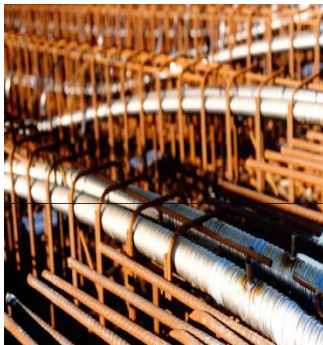
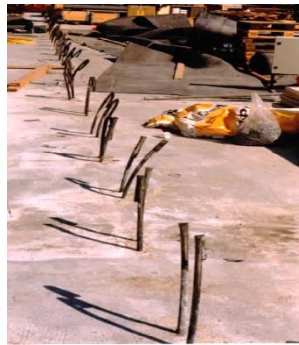
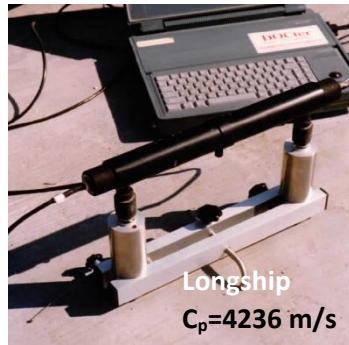
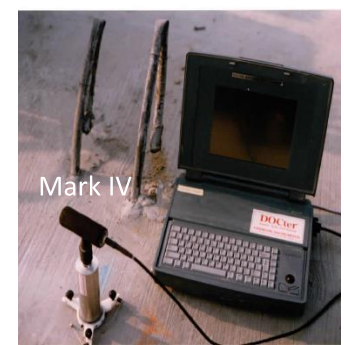
In Eastern part of Denmark, a large bridge slab was constructed, the slab being 110 cm thick with 40 cable ducts installed in the 40 m span of the slab. After tensioning of the strands injection grouting was performed, partly by pressurizing the grout from tube “A” shown in the cross-section and partly by pressurizing from tube “B”.

After injection, the “B” tubes were bend and secured with a steel wire. It was noticed that the grout, after injection, seeped out through the anchor ends, naturally causing a vacuum at the highest point in the cable duct, around the tube “B” inlet.

First, the wave speed C_p was estimated using the Longship illustrated above, the C_p was measured to be 4236 m/s.

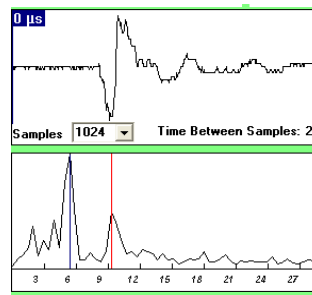
Typical signals are shown below, for a solid and for a voided duct

Unchanged solid frequency at 5.4 kHz. The P-wave runs right through the cable duct as it is also reflected at 9.3 kHz, the tendon strands at 9.3 KHz. **SOLID DUCT**

The solid frequency has dropped indicating the P-wave runs around a void. Strong 18.6 k frequency, related to 114 mm – the depth to the void in the **VOIDED DUCT**

After hardening of the grout all tubes were cut at the surface of the slab and inspection made through the “B” hole. Of the cable ducts investigated 25% were not injected, matching 100% the DOcter Impact-Echo findings. Re-injection was recommended to be done through the “B” tube hole.
