## Case 8.5 Impact-echo testing of a concrete silo wall for delamination

The cylindrical RCC 190 mm thick wall of an in-use cement silo, in the state of Rajasthan - India was recommended for Non-Destructive Testing after the in-house inspection team at the cement plant observed deterioration in the silo wall during routine inspections.

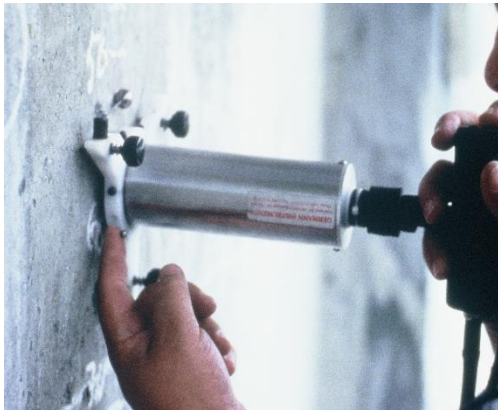
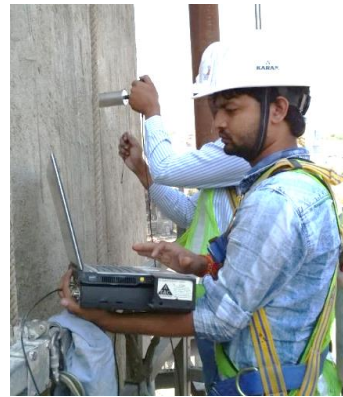
Avantech team carrying out Impact Echo test on wall of silo using the DOCTer Impact Echo Test System

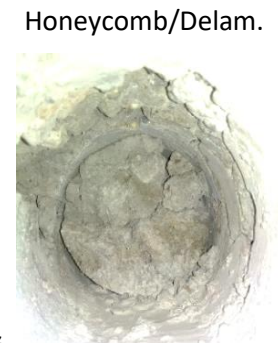
The solid frequency has dropped to 8.90 kHz. Multiple peaks appear in the frequency spectrum indicating a honeycombs, confirmed by coring.

18% of test locations exhibited delaminations/honeycombs and 8% reduced wave speed. The results were handed over to the inspectors for further action.
