NDTitans in action

Case 8.7 Crack depth estimation with Impact-Echo on a bridge deck in Medaryville, USA

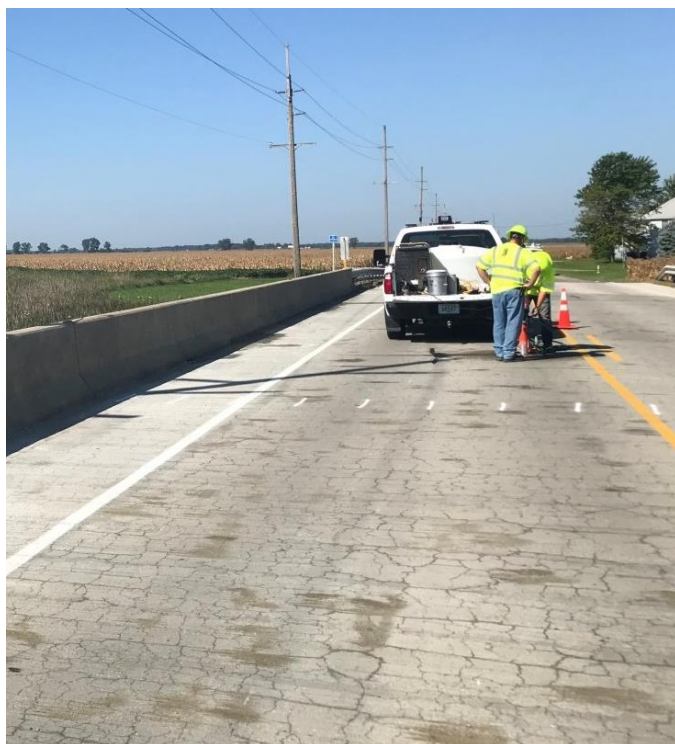
A concrete overlay cast over the existing deck of a bridge located in Medaryville, Indiana, USA, exhibited generalized cracking. The available documents and drawings showed that the thickness of the overlay was specified to be 1- $\frac{3}{4}$ ", however, after drilling some cores, the thickness was found to be up to 6" in some areas.

The cracking was evenly distributed along the length of the bridge, even in both ends of the bridge where the overlay had different conditions. There was concern about knowing how deep the cracks were in order to make decisions on the best way to solve the problem.

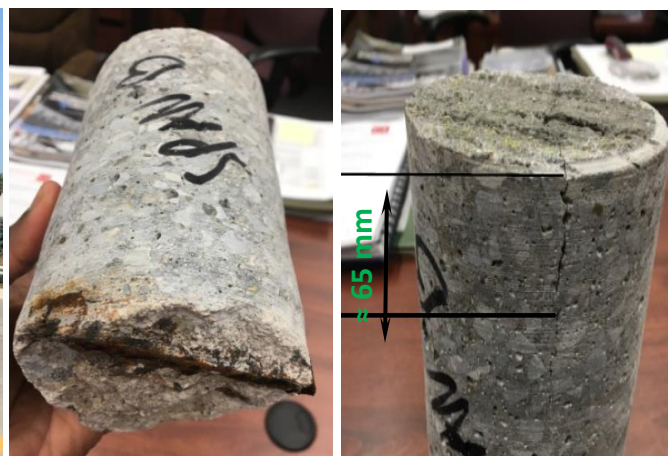
Two cores were taken to corroborate the results and the actual measured depth matched reasonably well with the results obtained. In the top right photo, the crack is 65 mm deep while Impact-Echo calculated 67 mm in that particular point.

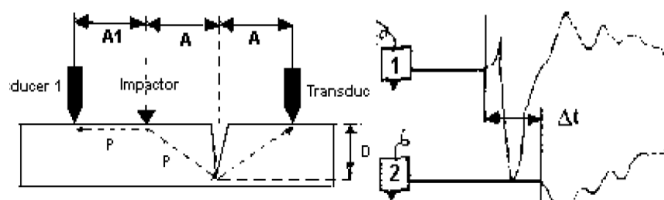
The P-stress wave velocity in the concrete was first measured with two displacement transducers placed at a certain distance. With this value, the transducers were positioned as shown in the bottom right picture with a distance $A = 50$ mm. The P-wave produced by the impactor travels on the surface to transducer 1 but cannot pass the surface opening crack, so it travels down along the side face of the crack, it is refracted at the bottom of the crack and returns as a tension wave to transducer 2. The geometry of the travel paths and the time

intervals measured with the transducers allow calculating geometrically the estimated depth of the target crack.
