## CASE 4.9 NDT & Strength Evaluation of an Industrial Warehouse, Mexico

A Graphite Electrodes’ manufacturing company requested a full structural condition assessment of one of their industrial warehouses in Monterrey, Mexico. After the evaluation, decision would be taken regarding the demolition or repair of the structure. The 50-year-old structure was fully built with cast-in-place reinforced concrete elements. The structure consisted of regular rectangular columns and beams, and a large semi-circular vaulted roof. The longest dimension of the roof from edge to edge was 124 meters. Since the owner of the structure didn’t allow coring, a full NDT evaluation program was conducted..

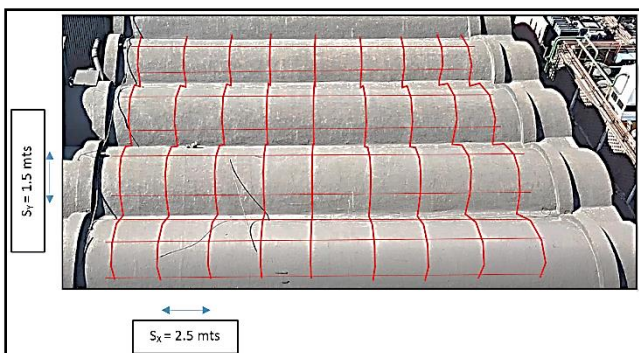
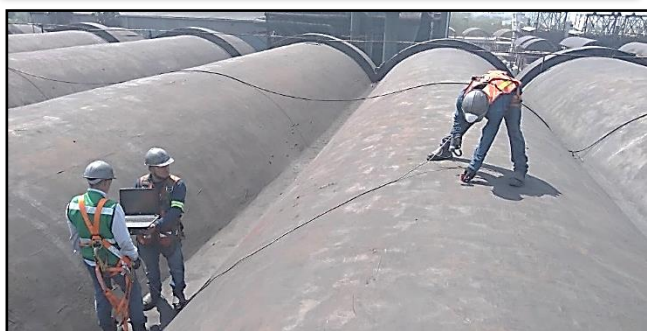
s'MASH contour plot of average mobility

s'MASH Impulse-Response was conducted to quickly evaluate the structural integrity of the large concrete roof. 8,600 m<sup>2</sup> of roof were tested with around 1,200 points in 1 a full day.

The “average mobility” value of each point was used to compute a statistically modified contour plot as shown with the “sound” areas (blue) vs “unsound” areas (red / yellow) It was found that the areas where high “average mobility” (red / yellow) coincided with heavy corrosion induced damage from carbonation.

Using the calculated equivalent compressive strength as suggested by ACI 228 and the on-site rebar configuration, it was found that the structure was appropriately designed and built. However, after 50 years of service, the structure had developed localized carbonation induced corrosion deterioration on beams and especially the roof, and needed repair. Columns were suffering from mechanical impact due to negligent driving of tractors within the warehouse. A concrete rehabilitation manual was provided to the structure owner.
