## Case 6.1 BOND-TEST for evaluating runway joints, Anchorage, Alaska

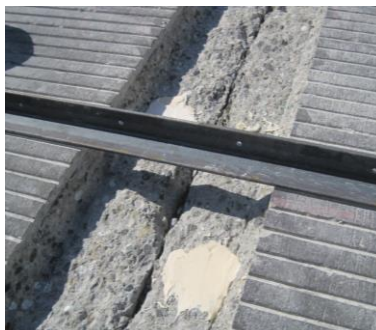
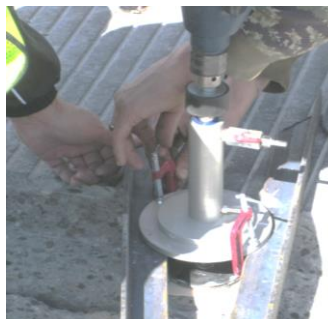
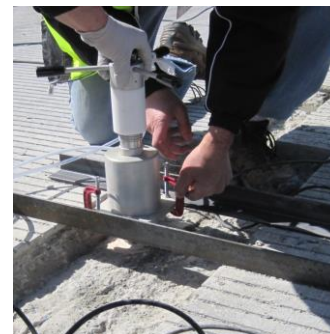
Planning of the adhesive perpendicular to the surface, gluing on of the disc to the planned adhesive (not shown) and finally coring of the partial core centric with centerline of the disc, using the CORECASE.

Notice: No planning of the substrate itself is done.

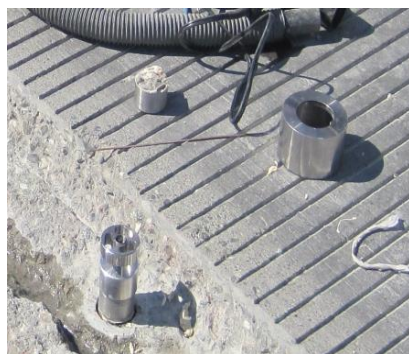
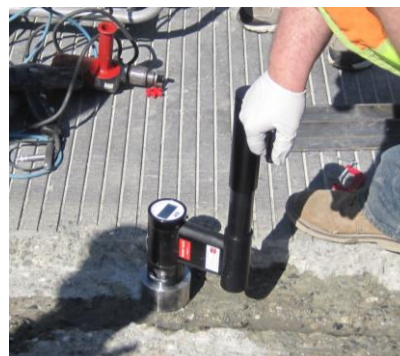
Testing in progress shown below with the BOND-TEST hydraulic pullmachine being loaded at a constant loading rate until rupture of the concrete, max pullforce recorded and saved and tensile strength  $f_t$  calculated

BOND-TEST Results		
Testing of	Values	Failure
"Sound" concrete	440 psi (3.0 MPa) to 550 psi (3.8 MPa)	Bottom failure
Bottom of channel, before water jetting	15 psi (0.1 MPa) to 120 psi (0.8 MPa)	In concrete
Bottom of channels after water jetting	290 psi (2.0 MPa) to 370 psi (2.6 MPa)	Bottom of partial core
After casting of new joint	280 psi (1.9 MPa) to 380 psi (2.6 MPa)	80% in substrate 20% in adhesion

Summary of test results. As will be seen, the adhesion strength of the repaired joint exceed the requirement of 1.7 MPa regardless of the position of the failure.

The joints repair was accepted
