Case 8.2 Injection quality of old cable ducts with impact-echo, Florida, USA

Fort Lauderdale bridge Florida, USA

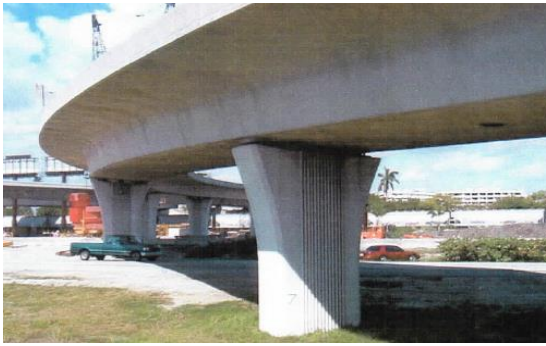
The 15 years old bridge is a cantilevered box girder bridge containing cable ducts, longitudinal as well as transverse in the bridge deck. The owner FDOT requested testing of the ducts, performed by impact-echo. Due to the cantilevered shape, evaluation had to be done directly from the ducts, only. The ducts were located by GPR in the bridge deck, and testing made by DOCTer impact-echo in the centerline of the ducts.
