Case 8.3 Duct inspection of a three-span bridge in the West of Ireland with the DOCTer

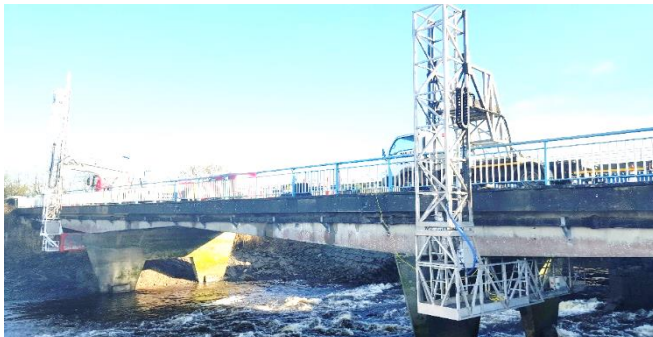
Conducted by Infrastruct Ireland, a Special Inspection was first performed to examine the condition of the concrete elements forming the bridge (designed in 1966), incl. surveys for cover, half-cell potential, resistivity, UPV and localised breakouts to examine the type and condition of the reinforcement and concrete sampling to establish the compressive strength of the concrete, the carbonation depth, the cement content of the concrete and the chloride ion content.
