NDTitans in action

Case 10.5 Non-destructive evaluation of a Stress Ribbon Bridge, Czech Republic

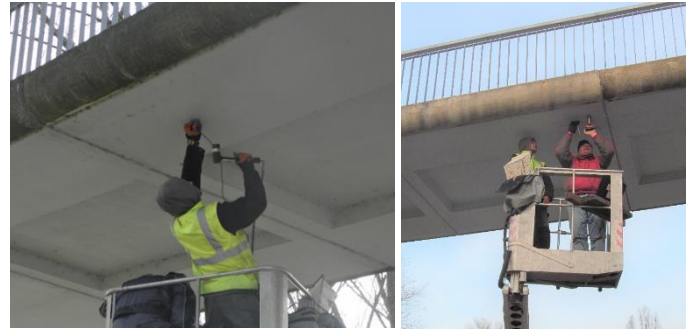
After the collapse of the Troja stressed ribbon concrete footbridge in Prague, Czech Republic, due to corrosion of the prestress steel strands, **NDTitans Claus Petersen, Malcolm Lim and Hugo Orozco** were invited to demonstrate the feasibility of utilizing different nondestructive testing techniques to evaluate the current condition of similar stress ribbon bridges located in the country.

A visit to the salvage yard where several damaged pieces of the 34-year old Troja bridge could be inspected, allowed to identify the possible causes that lead to deterioration of the tendons. It was noticed that some of the ducts for the Type B tendons were only partially grouted and that there were signs of water leaking through the joints between the precast segments. Also, it was evident the bad quality of the concrete used to cast the gutters where the Type A tendons were embedded without ducts. There was honeycombing in several locations and also, excessive shrinkage of this concrete produced cracking, especially along the perimeter in contact with the concrete of the precast elements, allowing the water leaking from the joints to easily flow and come into contact with the tendons.

With this experience, the ND testing was then carried out over the three-span, 200 m long, Nymburk bridge, located on the Elbe River at about 45 km east of Prague. The structure, construction process and age of this bridge are similar to the Trojan bridge.

The **MIRA** Ultrasound-Echo tomographer and the **DOCTer** Impact-Echo system were used to try to find poorly grouted ducts for the type B tendons. However, the MIRA signal could not penetrate and reach the ducts because of the heavy layer of reinforcing bars below the ducts. With an adequate selection of the impactor, the DOCTer could apparently do the job by identifying some suspicious points where the ducts could have voids (dropping of the solid resonance frequency).

For the case of the Type A tendons, the purpose was to identify the defective (cracked, voided) concrete in the gutters by using the **s'MASH** system based on the Impulse-Response method. With this quick method, it was expected to find higher mobility values in cracked or voided concrete than in sound concrete. The mobility contour plot shows the areas of potentially defective concrete where the tendons might have started an active corrosion process.
