# NDTitans

Now the TITANS are back – the NDTitans, specialized in Non-Destructive Testing (NDT) of materials from the crust of the Earth.

**NDTitans** is an international group of highly specialized, skilled, and dedicated engineers, scientists, and companies with many years of structural engineering and testing experience related to all aspects of concrete and reinforced concrete structures. The **NDTitans** are from Denmark, Finland, Poland, Greece, Ireland, India, Mexico, USA and Canada.

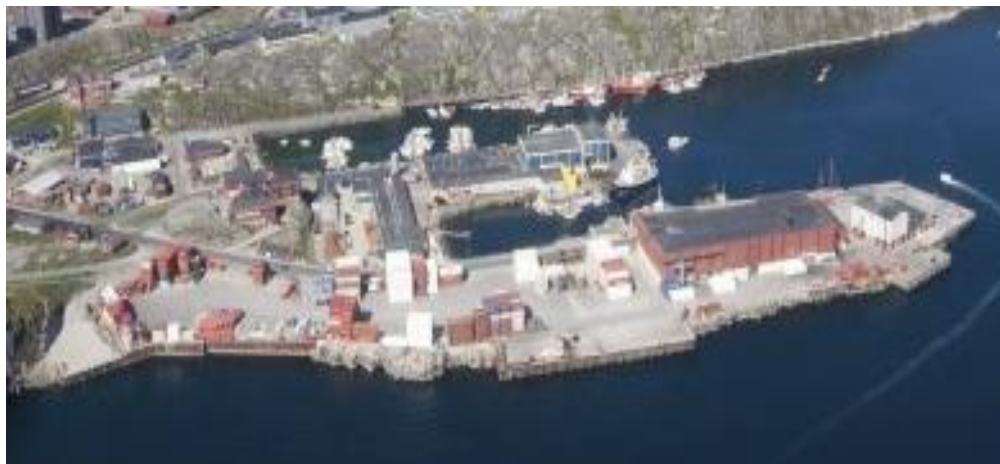
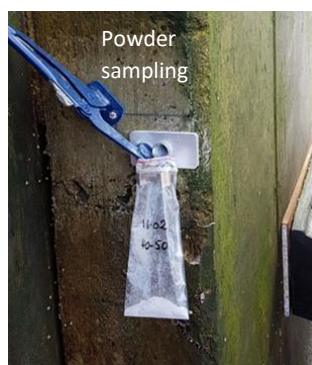
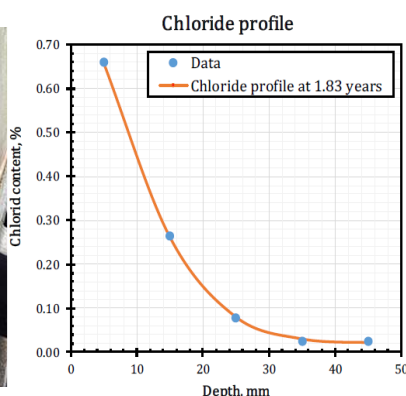
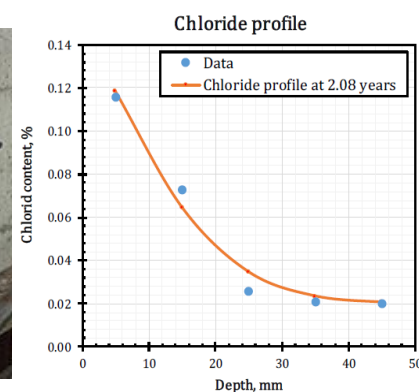
### Service life estimations, the Nuuk Container Terminal, Greenland

In 2013 the construction began of the new 47,000 square meter container terminal in Nuuk, Greenland, and was opened to operation in 2017. Some months later, under suspicions of low strength concrete in some elements of the piers, investigations of chloride penetration in the cover layer were carried out using the **Germmann Instruments' RCT** (Rapid Chloride Test).

In a few elements, concrete powder samples were extracted by drilling at five different depths towards the reinforcement at 50 mm depth: 0-10, 10-20, 20-30, 30-40, and 40-50 mm. The chloride content by weight of concrete at each depth was determined with the RCT method, and this chloride profile was used to estimate the service life of the steel reinforcement, understood as the estimated time at which a chloride threshold reaches the depth of the reinforcement and accelerated corrosion might initiate.

The conclusion seems to be that, despite the low concrete water-cement ratio of 0.37, the concrete design was improper for the exposure conditions. Simulations of predicted service life for the same concrete mix showed that additions of about 10% to 12% of silica fume or fly ash would have resulted in a service life above 50 years.

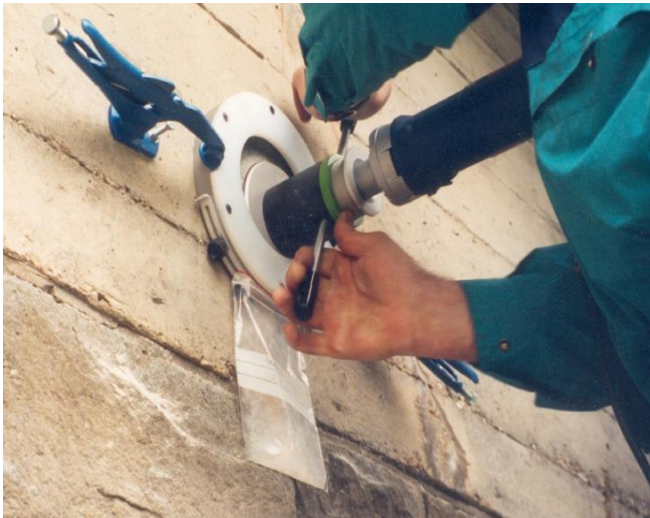
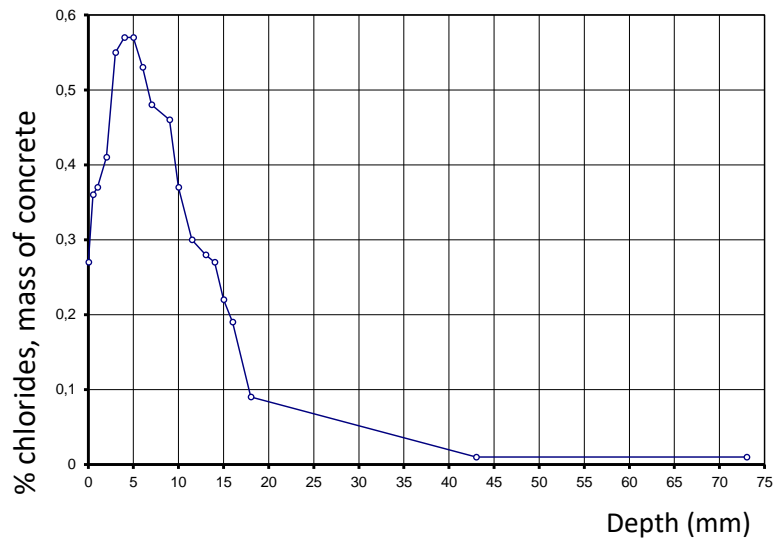
## Remaining Service Life of one-year old sea wall, at the splash zone, Denmark

The quality of the one-year old seawall's cover layer was questioned. The owner wanted an estimation of the remaining service life before corrosion would take place in the reinforcement based on the first year's ingress by diffusion of chlorides.

The cover was 50 mm.

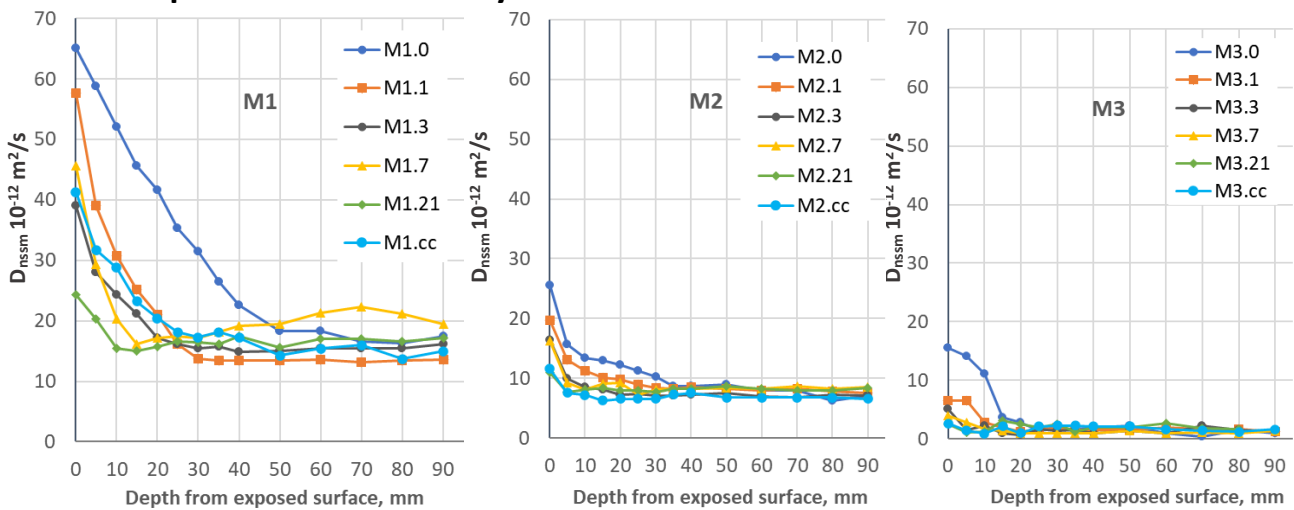
## LOK-TEST / CAPO-TEST for rapid in-situ screening of bad curing and its implication on durability and cost of structures.

It is well known that bad curing conditions affect not only the potential strength of the concrete, but also its durability in terms of penetration of deleterious ions such as chlorides that causes corrosion of the steel reinforcement in structures exposed to marine environment or deicing salts.

While durability evaluation of concrete mixes is a common practice in the concrete industry for important projects, the evaluation is very seldom done in-situ once the concrete has been cast. This would indicate what the effect of the real curing conditions is in the expected service life of the structure, in contrast with the well curing conditioning of lab specimens.

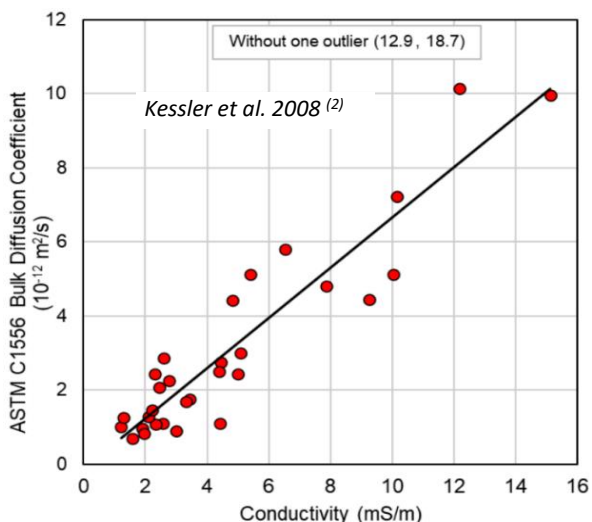
For instance, one property that does have a fundamental relationship to chloride diffusion is the electrical conductivity (or its inverse, resistivity). In the literature, one can find published relationships between the chloride bulk diffusion coefficient determined by ASTM C1556 vs. conductivity, and this property can be easily measured in the cover layer if a core is extracted from the suspicious area and the top end is sliced away for testing with the **MERLIN** conductivity/resistivity meter.

This conductivity value can be compared with the one obtained from the inner part of the core. The difference finally allows us to estimate the increase of the diffusion coefficient caused by the affected cover layer as well as the inherent implication in service life and future maintenance costs.

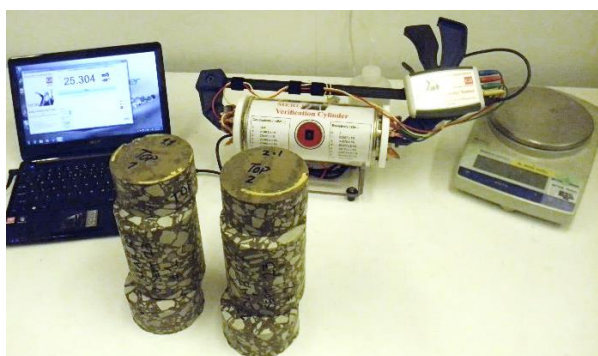
In order to evaluate the consequences in durability, two cores, 100 mm in diameter and 230 mm long, were drilled out. A 50 mm thick slice was cut from the top end of the cores (the cover layer) and conductivity measurements with MERLIN were performed on these slices and compared to measurements of the center part of the cores (bulk concrete).

Core:	C1	C2	Avg.	$D_{cl}$ ( $10^{-12} \text{ m}^2/\text{s}$ )
Cond. cover layer (mS/m)	13.5	13.9	13.7	9.3
Cond. bulk concrete (mS/m)	9.8	10.2	10.0	6.0
Difference	-27.4 %	-26.6 %	-27.0 %

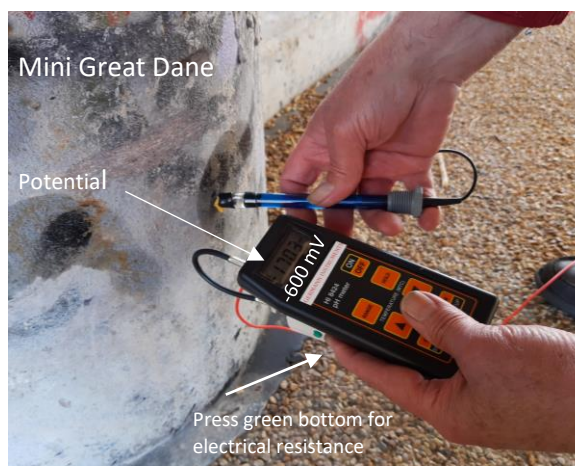
## Electrical resistance and potentials for corrosion evaluation, Denmark

Electrical Resistance (kOhm)						level
25	21	20	14	18	26	75 cm
20	26	20	8	10	19	60 cm
18	19	15	6	10	20	45 cm
10	8	6	4	7	10	40 cm
2	0	5	2	2	1	25 cm
0	0	0	1	0	0	10 cm

A 5-year old highway bridge column, close to the traffic lane, exhibited a crack (width 0.2 mm) vertically in the column. Suspecting corrosion of the rebars from splash water with chlorides, the following investigation was made.

Evaluation: From 40 cm height and downwards the electrical resistance of the cover layer is low, indicating presence of moisture and chlorides.

The potentials are low in the same region with the lowest potentials at the footing, close to the crack, -600 mV. The cover was opened at the location at the lowest potential and the reinforcement was corroded in pits, as illustrated above.

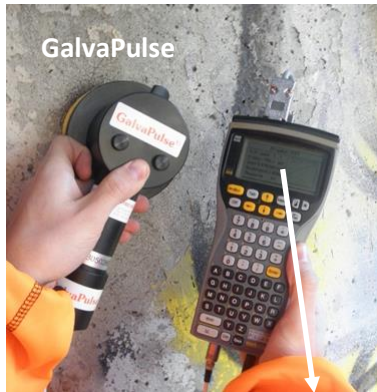
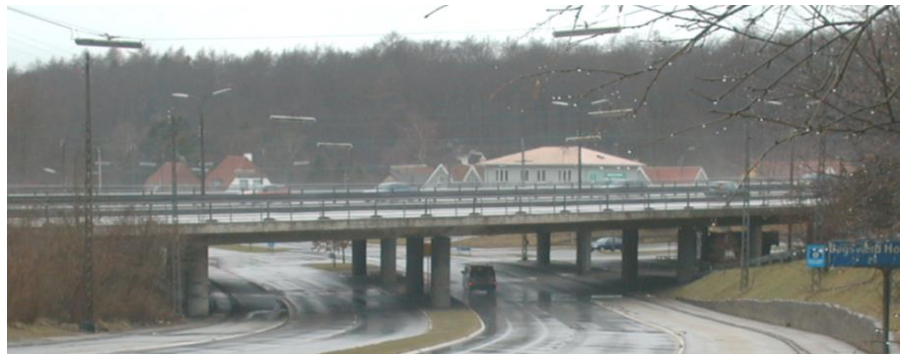
## Corrosion rate, Electrical resistance, and Potentials for corrosion evaluation, Denmark

Highway bridge with deteriorating columns at the footings

M: \galva\44	
X,Y - point 8 , 1	<p>Polarization curve</p>
E-corr. -388.0 mV	
Icorr 15.85uA/cm2	
Resistance 0.2 KOhm	
Measured 61

$i_{corr} = 15.9 \mu A/cm^2$   
or  $\approx 190 \mu m/year$

The Ag/AgCl potential is -388 mV and the electrical resistance 0.2 kOhm, indicating high corrosion risk and a moist cover layer, probably contaminated by chlorides. The polarization curve is regular and the corrosion current, calculated from this curve, 15.9  $\mu A/cm^2$ , equivalent to a loss of steel, following Faraday's Law, of 190  $\mu m/year$ , ~0.2 mm/year, highly active corrosion.

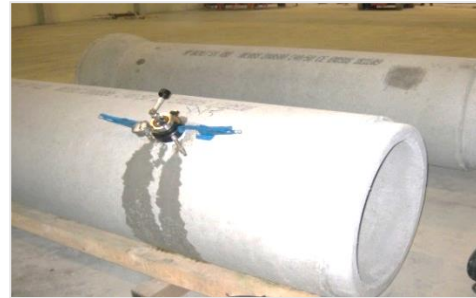
### Water tightness of sewer pipes

Correlations have been established between the speed of the GWT piston travel and the depth of water penetration using EN 12390-8 “Testing Hardened Concrete, Part 8: Depth of Penetration of Water under Pressure”. It has been found that the definition “watertight” concrete of <50 mm penetration depth (EN 12390-8) 72-hour pressure test relates to a GWT water flux of < 0.32 μm/min<sup>#)</sup> after 10

As will be seen, all sewer pipes passed the watertight requirement of a GWT flux <0.32 μm/min, except pipe GW-1.

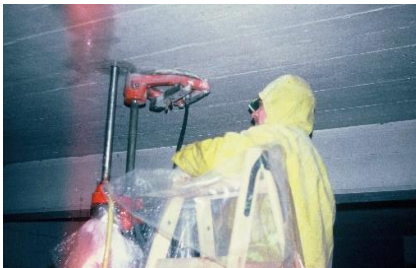
We drilled from below of the slab, 80 cm thick, to ~28 mm from the surface.

Broke the core and drilled a center hole, 8 mm in diameter, planed the surfaces for a 25 mm distance, inserted a LOK-TEST disc from below and threaded it into a pull bolt from above, connected to the LOK-TEST pull machine. Tested to failure and got 28 kN as the pull force. One test lasted 1 day.

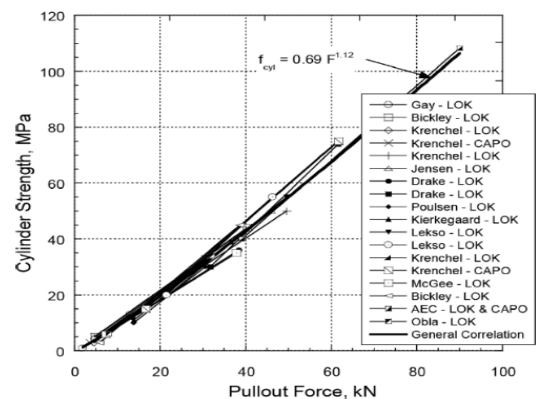
Fig.2. Eighteen correlations between pullout force and standard cylinder compressive strength.

From the experimental correlations found, fig.1 and fig.2, the following general correlations can be deduced:

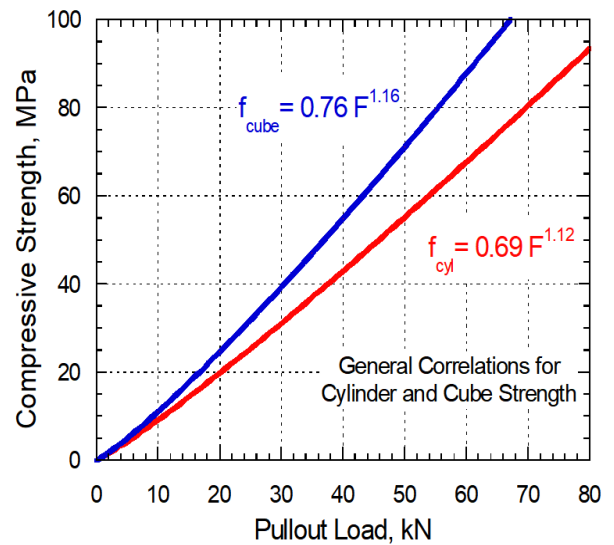
Fig.5. General correlations between pullout force (LOK or CAPO) and standard cube – and core - and standard cylinder compressive strength

**Note:** For the same concrete, the cube compressive strength is ~28% higher than the cylinder, as the stress distribution in standard cubes is tri-axial, while uni-axial in standard cylinders.

1. For standard cylinders (150 mm x 300 mm) compressive strength  $f_{cyl}$  in MPa related to pullout force  $F$  in kN, shown in fig.5:

$$f_{cyl} = 0.69 F^{1.12}$$
2. For standard cubes (150 mm x 150 mm x 150 mm) compressive strength and cores (100 mm dia x 100 mm) compressive strength in MPa related to pullout force  $F$  in kN, also shown in fig.5

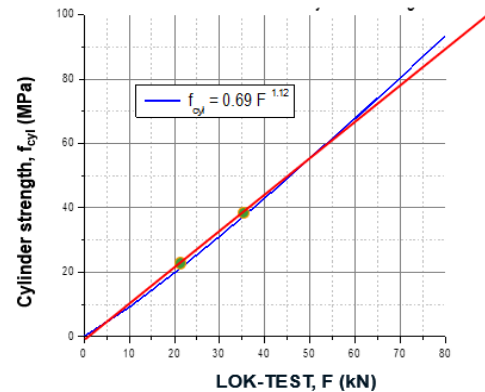
Comparing the general correlation for cylinder to pullout force to the two theoretical studies mentioned previous page from 1976 and 1982:

Fig. 6. The theoretical studies results (red line and dots) compared to the experimental found general correlation for uni-axial stress, the standard cylinder compressive strength (blue curve).

The results from the two theoretical studies, in 1976 and in 1981, are shown in fig. 6, comparing the uni-axial compressive cylinder strength to LOK-test pullout force

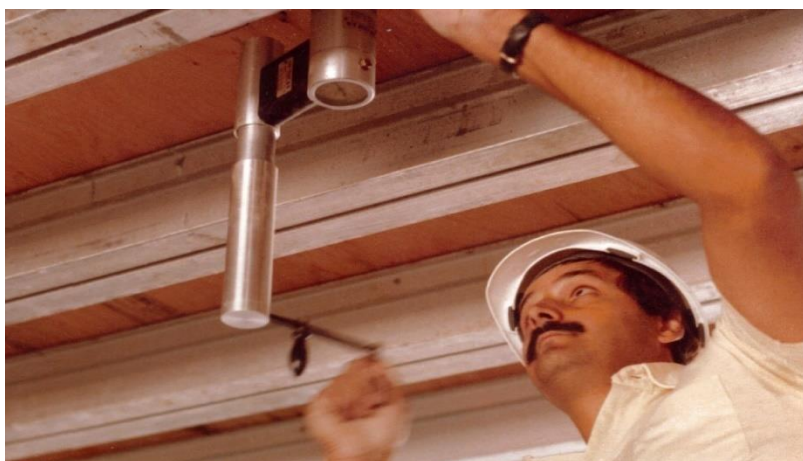
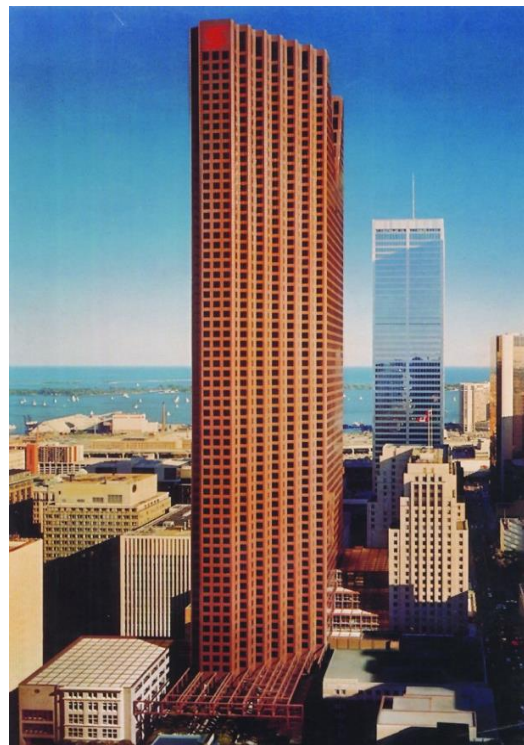
In a 100 m<sup>3</sup> slab pour 10 to 15 LOK-TEST inserts are installed equally distributed in the bottom of the slab as illustrated above through prepared port holes. Inserts can also be installed as floating inserts in the top, but the bottom installation is preferred due to simplicity.

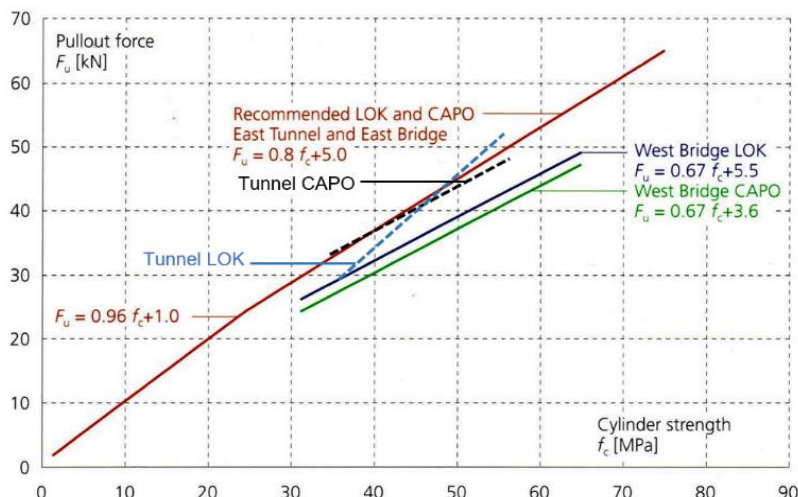
CAPO-testing on the Caissons of the GBL West Bridge

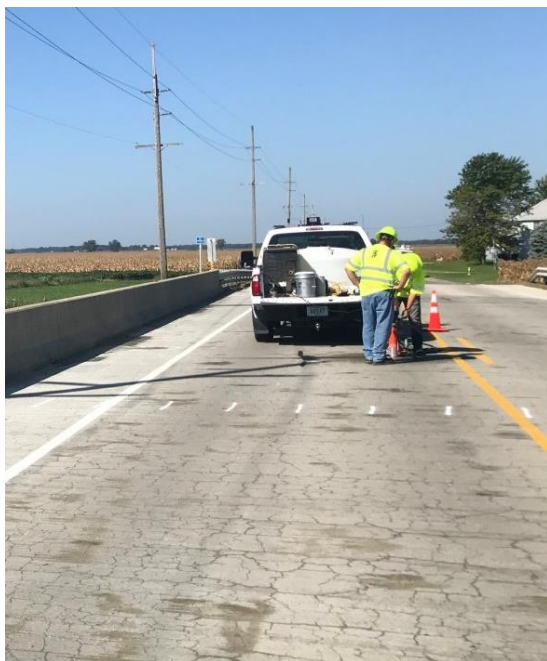
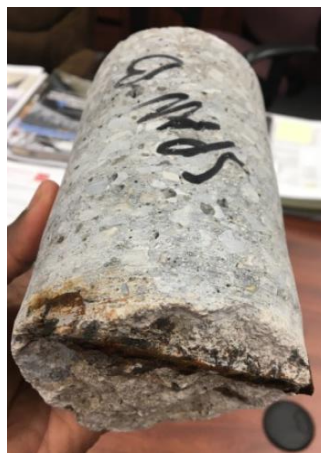
A concrete overlay cast over the existing deck of a bridge located in Medaryville, Indiana, USA, exhibited generalized cracking. The available documents and drawings showed that the thickness of the overlay was specified to be 1- $\frac{3}{4}$ ". However, after drilling some cores, the thickness was found to be up to 6" in some areas.

The P-stress wave velocity in the concrete was first measured with two displacement transducers placed at a certain distance. With this value, the transducers were positioned as shown in the bottom right picture with a distance  $A = 50$  mm. The P-wave produced by the impactor travels on the surface to transducer 1, but cannot pass the surface opening crack, so it travels down along the side face of the crack. It is refracted at the bottom of the crack and returns as a tension wave

to transducer 2. The geometry of the travel paths and the time intervals measured with the transducers allow calculating geometrically the estimated depth of the target crack.

The testing was divided into two locations. The average depth of cracking was found to be  $59 \pm 9$  mm in location 1 and  $85 \pm 7$  mm in location 2.

Two cores were taken to corroborate the results and the actual measured depth matched reasonably well with the results obtained. In the top right photo, the crack is 65 mm deep while Impact-Echo calculated 67 mm at that particular point.

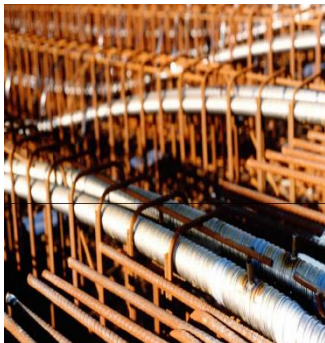
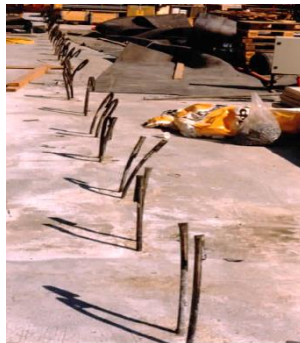
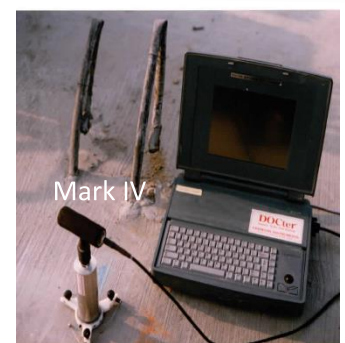
In the Eastern part of Denmark, a large bridge slab was constructed, the slab being 110 cm thick with 40 cable ducts installed in the 40 m span of the slab. After tensioning of the strands injection with a grout was performed, partly by pressurizing the grout from tube “A” shown in the cross section and partly by pressurizing from tube “B”.

Filling up of the mortar in the corrugated steel tube is quite important, not only because of stress transfer from the strands through the mortar to the slab, but also for protection of the strands from corrosion in the future.

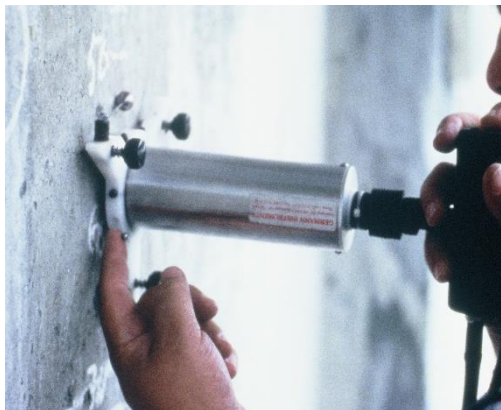
Avantech team carrying out Impact Echo test on wall of silo using the DOCTer Impact Echo Test System.

The cylindrical RCC 190 mm thick wall of an in-use cement silo, in the state of Rajasthan - India was recommended for Non-Destructive Testing after the in-house inspection team at the cement plant observed deterioration in the silo wall during routine inspections.

DOCTer Impact Echo Test equipment manufactured by Germann Instruments A/S Denmark was used to inspect the silo's RCC wall using the impact echo test method.

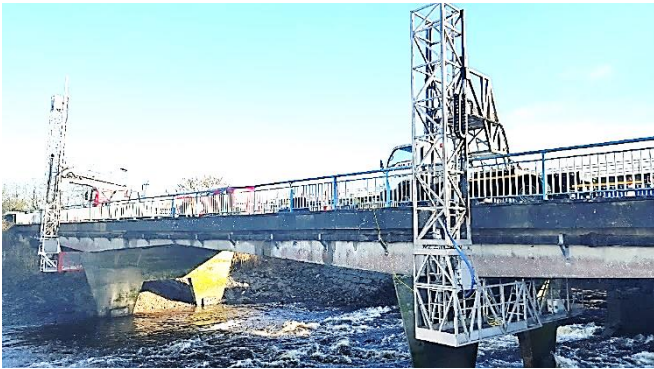
Conducted by Infrastruct Ireland, a Special Inspection was first performed to examine the condition of the concrete elements forming the bridge (designed in 1966), incl. surveys for cover, half-cell potential, resistivity, UPV and localized breakouts to examine the type and condition of the reinforcement and concrete sampling to establish the compressive strength of the concrete, the carbonation depth, the cement content of the concrete and the chloride ion content.

During the Special Inspection, post-tensioning ducts were located using GPR and a couple of exposures were made to the ducts and tendons. In two of the four ducts opened, fully voided ducts with corroded tendons were found. There was no evidence of water ponding within the ducts.

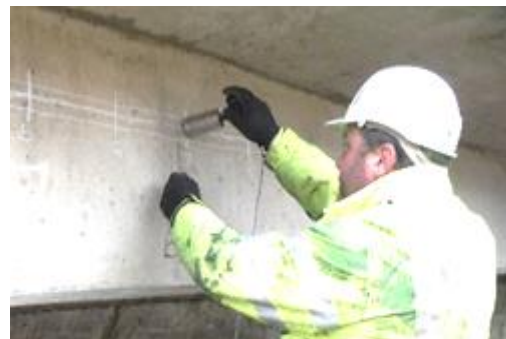
Impact Echo testing underway using the DOcter Impact Echo system to determine the ducts condition.

2000 Impact Echo tests were completed. 50% of the ducts were partially voided, 4% of the ducts were fully voided and only 46% of the ducts were found to be fully grouted.

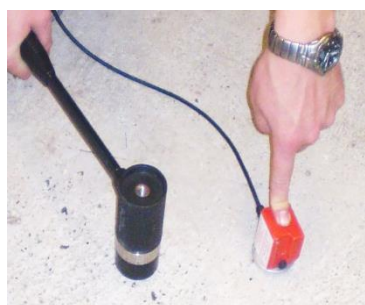
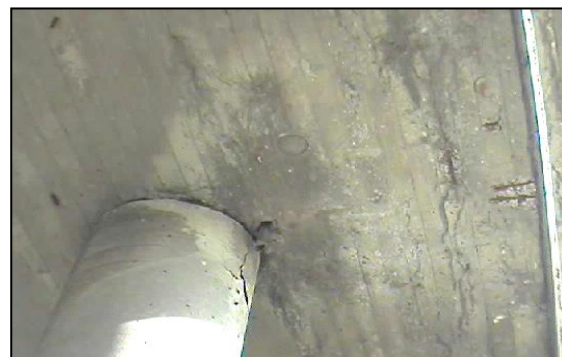
The soffit of a bridge slab showed starting deterioration at the edges. **Germann Instruments s'MASH** Impulse Response system was applied from the top of the slab.

Above is shown the instruments, a rubber tipped hammer with built-in load cell and a velocity transducer. A hammer stroke to the surface makes the member bend in a flexural manner, and e.g. the average mobility of the member is plotted.

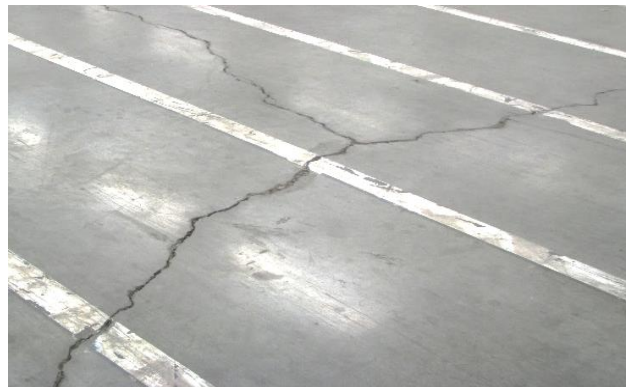
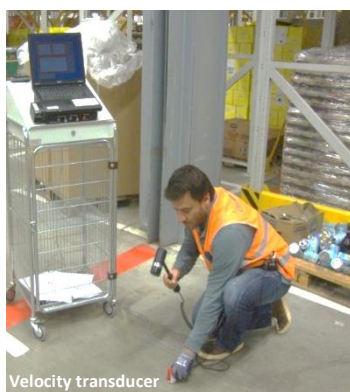
For speedy testing, the entire floor was tested with s'MASH Impulse Response, using its voids index option. Spacing between test points 1 m x 1 m. A section is shown below.

**NDTitan Nikos Zoides** doing the s'MASH testing and checking the voids index. The Voids Index is the maximum mobility peak divided by the average mobility, and if >1.6, a void is present (red and yellow color).

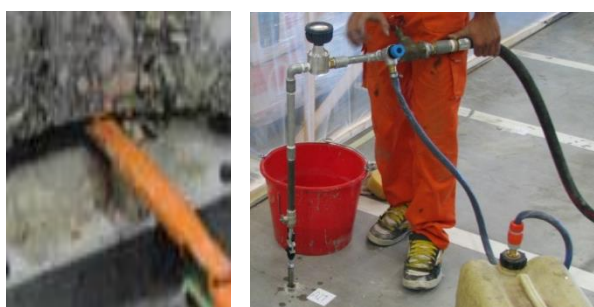
Coring confirmed the voids:

Subsequently, injection was made with a grout with a W/C ratio of 0,7 to 0,9 (under pressure of 2bars at the maximum) through 26 mm holes.

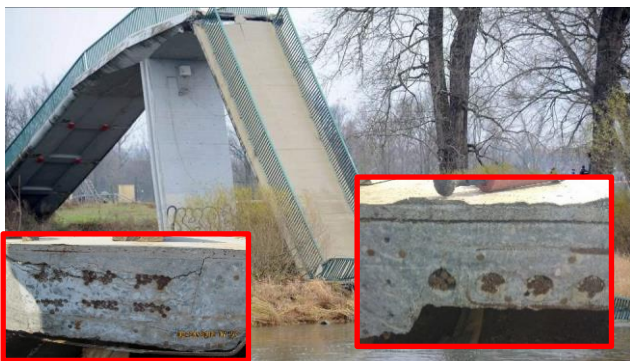
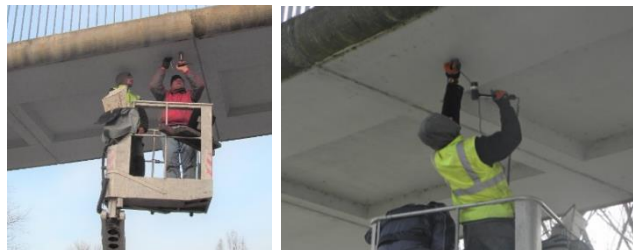
After the collapse of the Troja stressed ribbon concrete footbridge in Prague, Czech Republic, due to corrosion of the prestress steel strands, **NDTitans Claus Germann Petersen, Malcolm Lim and Hugo Orozco** were invited to demonstrate the feasibility of utilizing different nondestructive testing techniques to evaluate the current condition of similar stress ribbon bridges located in the country.

A visit to the salvage yard, where several damaged pieces of the 34-year old Troja bridge could be inspected, allowed the team to identify the possible causes that led to deterioration of the tendons. It was noticed that some of the ducts for the Type B tendons were only partially grouted and that there were signs of water leaking through the joints between the precast segments. Also, it was evident that the quality of the concrete was bad used to cast the gutters where the Type A tendons were embedded without ducts. There was honeycombing in several locations and, also, excessive shrinkage of this concrete produced cracking, especially along the perimeter in contact with the concrete of the precast elements, allowing the water leaking from the joints to easily flow into contact with the tendons. With this experience, the ND testing was then carried out over the three-span, 200 m long, Nymburk bridge, located on the Elbe River at about 45 km east of Prague. The structure, construction process and age of this bridge is similar to the Trojan bridge.

A preliminary visual inspection found moisture stains on the underside of the bridge caused by the water leaking through the joints as well as a few spots with minor spalls and reinforcing bar corrosion. Additionally, it was found that a thin repair overlay cast over the deck of the bridge had debonded in many areas which made it impossible to use the NDT systems without removing it. Thus, it was decided to perform the testing from the underside of the bridge.

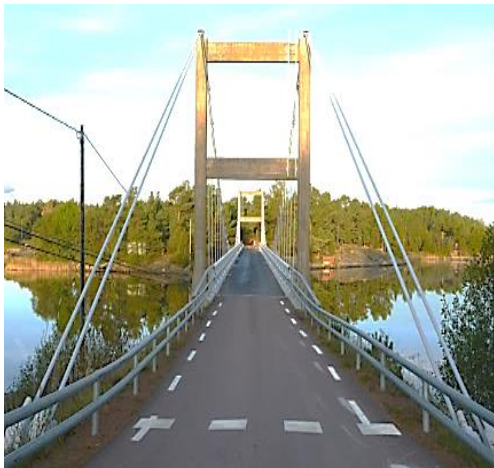
One year after completion of renewal (repair planning by G. Rapaport) the deck surface of the suspension bridge at the Åland islands (Finland) showed localized minor damages.

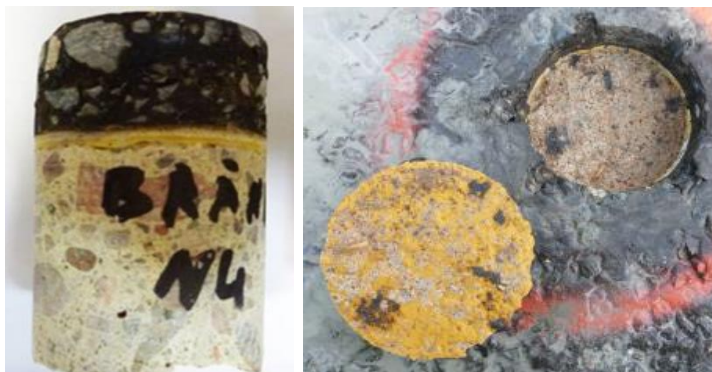
Validation points S4 and S3

S4 (green area) bonded waterproofing, BOND-Strength ft=1.0 MPa (req.  $\geq 1.0$  MPa)  
S3 (red area) waterproofing debonded.

Conclusions & Recommendations: Good correlation between NDT and validation.

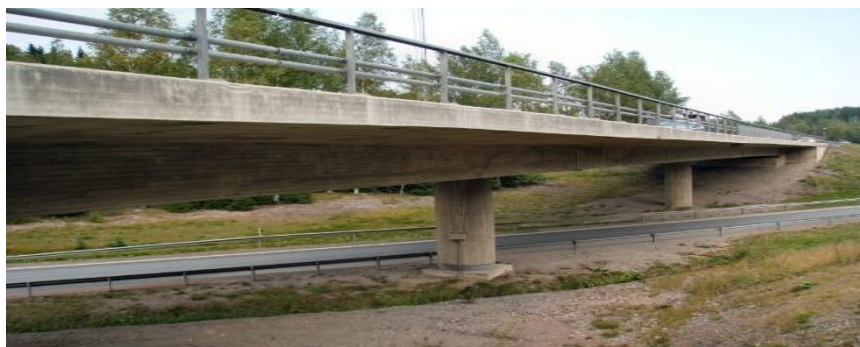
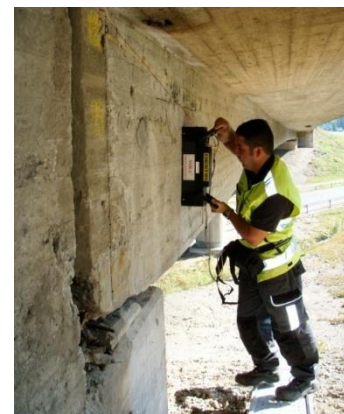
Evaluation of prestressing duct's condition (Ramboll Finland Oy) at various locations along the bridge, mostly at the anchoring zones and mid spans was performed by using the MIRA ultrasound tomography and Impact-Echo on the Leiviö over bridge in Finland for the Finnish Road Administration.

DOcter Impact-Echo and the MIRA identified the same conditions of the injection of the cable ducts as well as in the first area of the injected duct (the red color) found to be partly injected.

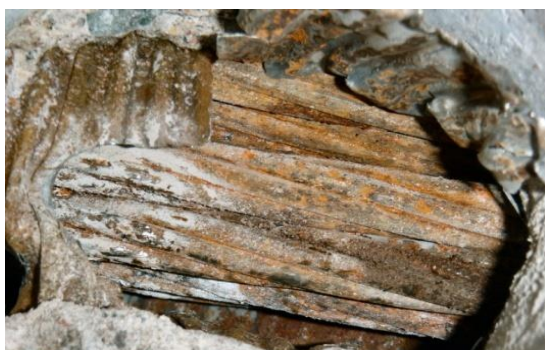
At one location it was decided to open the suspicious duct at a distance of 1 m from the head of the anchor holding the strands, carried out by coring to the corrugated tube, which was opened as well.

The finding is illustrated below.

The duct was empty of injection grout and the strands were severely corroded, yet only mildly pitted.

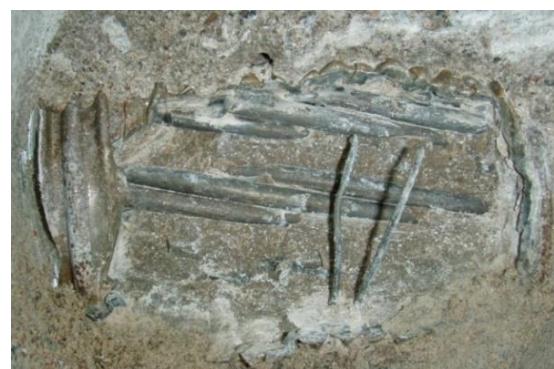
In comparison, in another area, where the MIRA did not show intensive reflections (red color), but only slightly green/yellow color (non-suspicious), another similar opening was made.

As seen, the strands were fully encapsulated by injection grout, well protected. The strands are in good condition with no signs of corrosion.

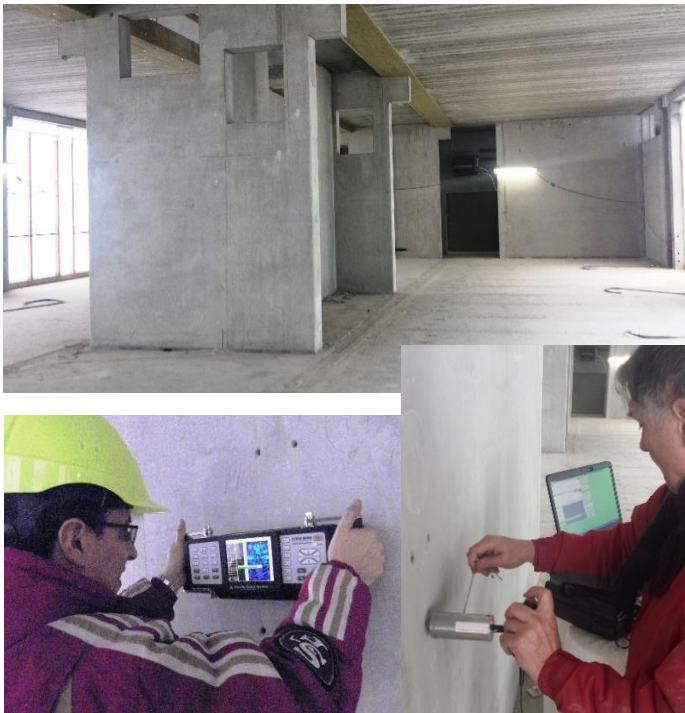
## Non-destructive testing of joints in precast walls

In 2015, a new building complex in the Technical University of Denmark, DTU, was under construction. A demonstration of quality inspection of grouted joints reinforced with looped wire ropes was performed in the Life Science & Bio Engineering multi-story building where precast concrete walls were used. Knowing that the grouting process is very susceptible to human error, looking for possible defects is critical. Two instruments were used, the **DOcter**, which is based on the Impact-Echo method, and **MIRA**, an ultrasonic-echo tomographer. These stress wave, NDT assessment methods, are well known to be sensitive to these types of defects.

A vertical column of 17 to 18 testing points, with 100 mm spacing in between, were made for inspecting each of two randomly selected joints. The tested concrete walls were 200 mm thick. By analyzing the changes in the value of the resonance frequency compared to that of a solid part of the joints (9.5 kHz), Impact-Echo was able to identify the position and depth of several voids. The 2D images or B-scans made with MIRA corroborated the findings.

The contractor also extracted some cores and verified that the position and extent of the defects matched very well

with the NDT results. It was later discovered that many joints had the same problem and that it might affect the structural performance and durability of the elements. Drilling and reinjection of most of the joints had to be done to repair them.

The **Germain Instruments' NDTitans Claus Petersen and Hugo Orozco** are shown performing Impact-Echo and MIRA tomographer, respectively.

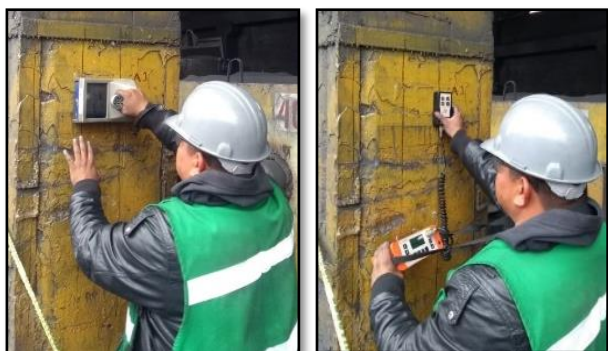
Ground Penetrating Radar with a 2600 MHz antenna was used to scan the structural elements and Cover Meter was used to estimate the rebar diameter. It was found that the average cover layer of all columns and beams was 20 mm.

GPR for rebar depth      Covermeter for size of bar

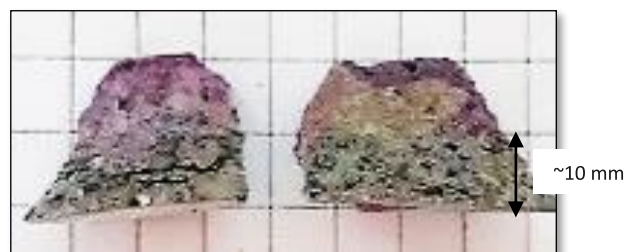
### CARBONATION

The CAPO test conical pull-out cones were tested for carbonation with a pH indicator. It was found that the depth of carbonation on columns was ~10 mm and the beams and roof ranged between 15 to 30 mm. The average cover layer was 20 mm. The reinforcement of beams and roof was at high risk of corrosion.

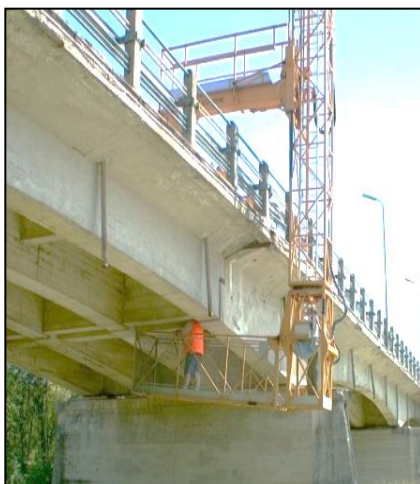
**Rainbow Indicator** and **Deep Purple** for depth of carbonation on a bridge girder

The Deep Purple and the Rainbow Indicator produced the same depth of carbonation, from the inside of the girder 54 mm and from the outside 25 mm. The reason for the **different** depth is that the outside is subjected to rain, slowing down the carbonation process, while the inside is relative dry.

Carb. depth 54 mm  
Inside of Girder

With the depth of the reinforcement 40 mm, misleading information concerning the protectiveness of the reinforcement could be given if testing was only made from the outside of the girder. The reinforcement positioned at the inside of the girder had in fact started corroding, while reinforcement at the outside had no signs of corrosion.

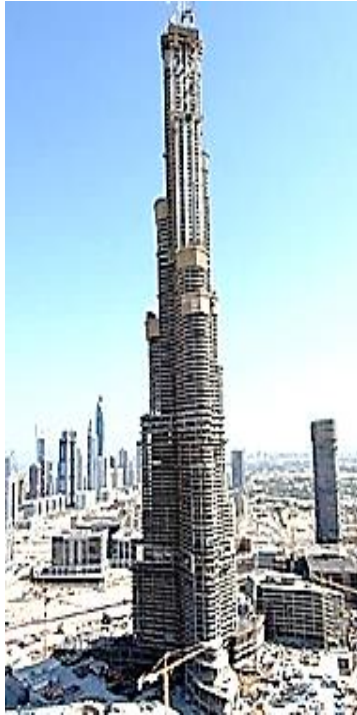
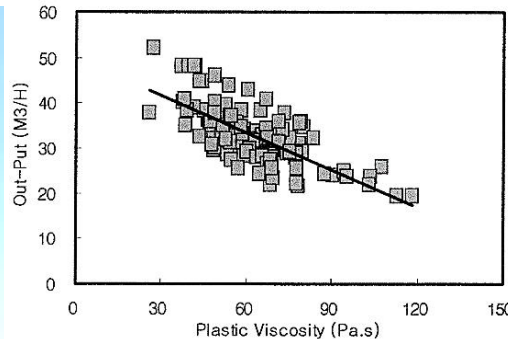
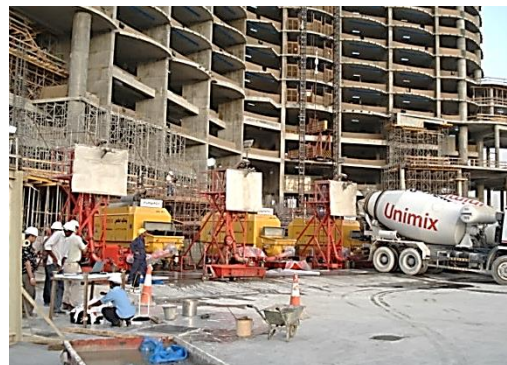
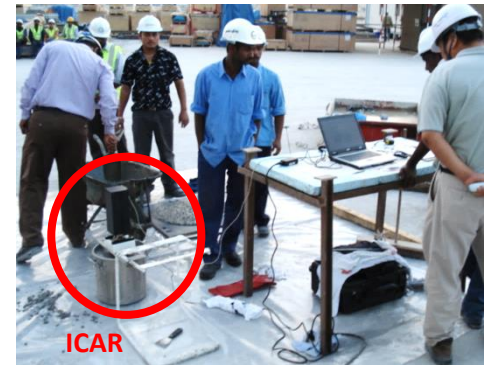
## Rheology in the Burj Khalifa Dubai Super Tall Building

For this purpose, the **ICAR Rheometer** was extensively used both during the trials and the construction process. At the beginning, pumping through the 150 mm diameter high pressure pipes was found to be approximately half the plastic viscosity of the concrete and double the dynamic yield stress. Also, correlations of rheological properties vs. key pumping parameters like friction factor and out-put flow were developed. These findings created the ability to optimize the concrete mixtures and procedures of systematic quality control to carry out the actual works.

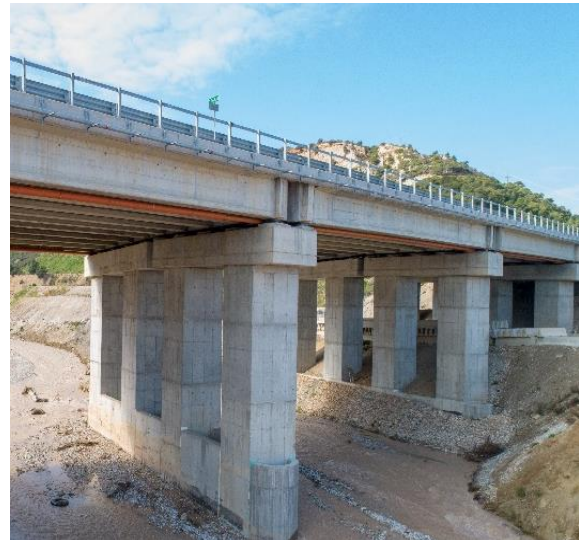
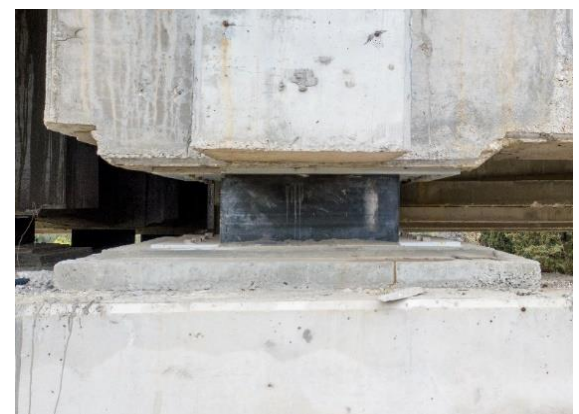
The soffit of the decks was inspected, the pier caps and the elastomeric bearings. Some bridges are above river crossings and inevitably access to elements demand the use of underside platform if there were no Drones. The visual inspection comprised, furthermore, traces or moisture that could indicate deficiency of waterproofing system over deck and expansion joints.

Finally, excessive deformations, bulging and oxidation of elastomeric bearings was performed with drones in a fast and efficient way with low cost.

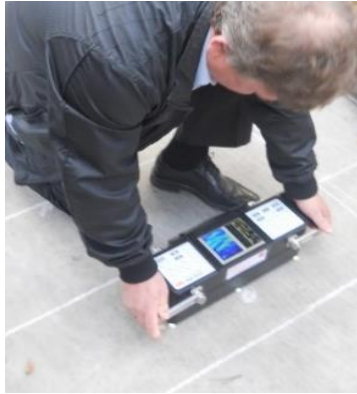
Slab with known defects, GI, USA

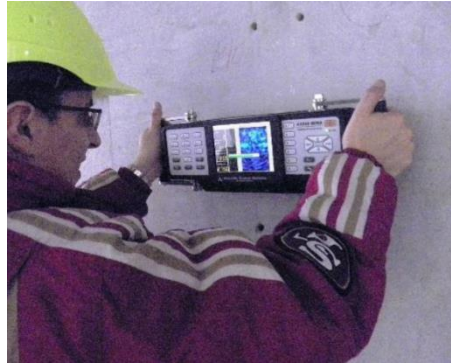
Joints at DTU, Denmark

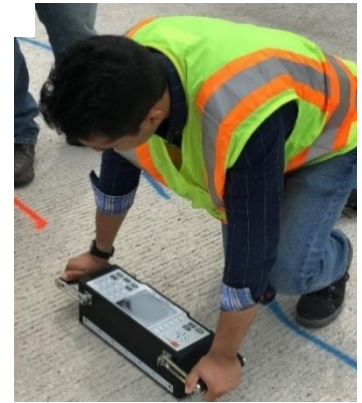
Bridge deck, FHWA, Illinois

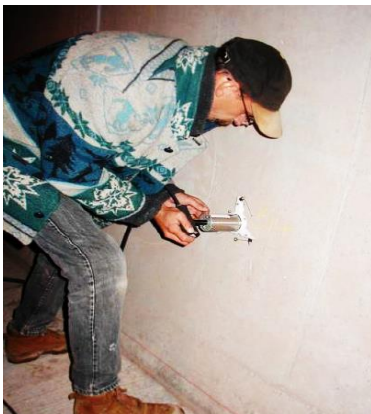
Tunnel thickness, Germany

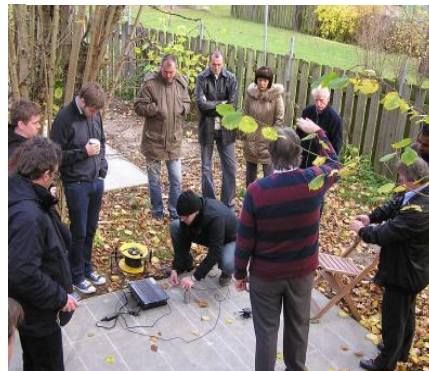
Slab with known defects, Denmark

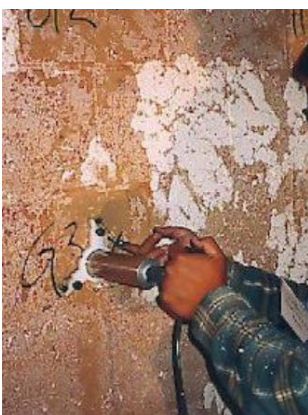
Pulp Plant, Canada  
De-bonding of tiles

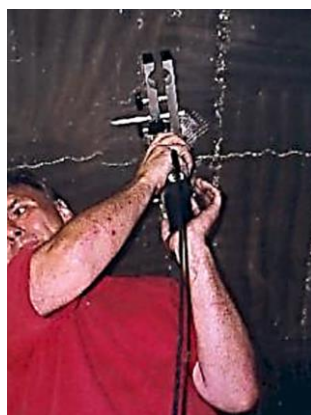
Fire damaged ceiling, Germany  
Depth of cracks

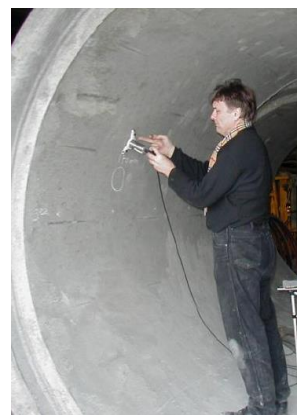
Sewer tubes, Denmark  
Delaminations

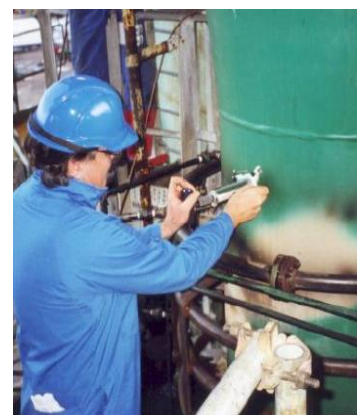
Thickness of concrete liner  
inside riser column, Sweden

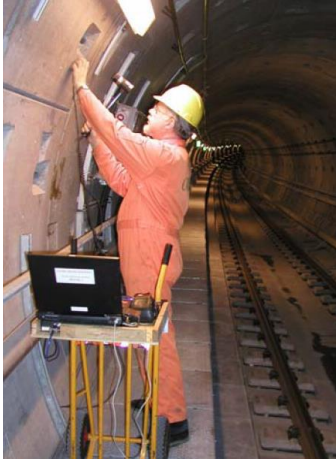
Tunnel lining, Denmark  
Voids in injection

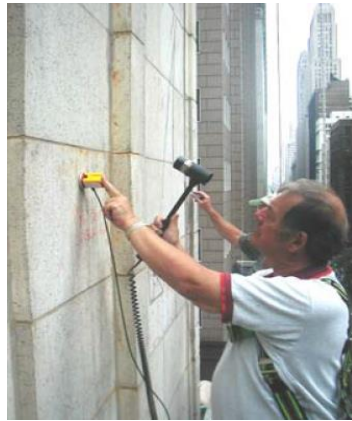
Terracotta Panels, Chicago  
Cracking / debonding

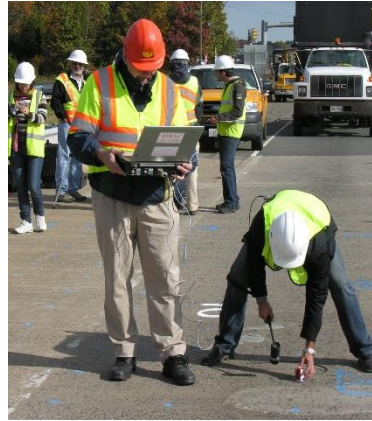
Bridge Slab, Virginia  
Voids / lack of support

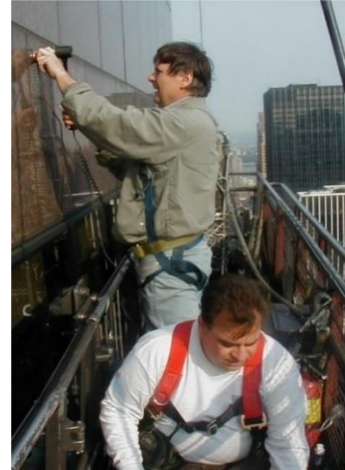
Granite Panels, New York  
Missing anchoring

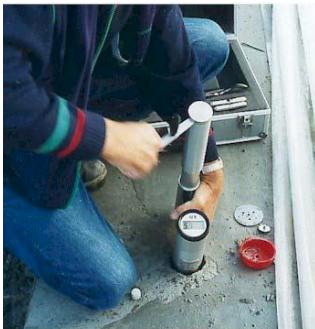
Industrial Floor, UK  
Strength before loading

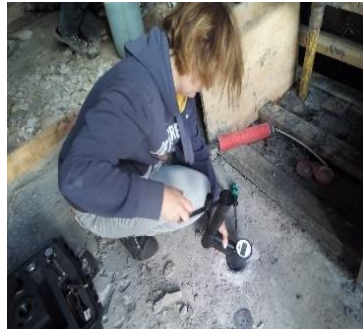
Tunnel Base, Denmark  
Strength before loading

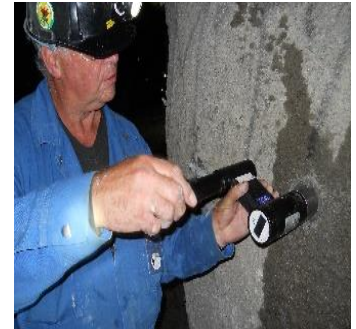
Shotcrete, Canada  
Strength

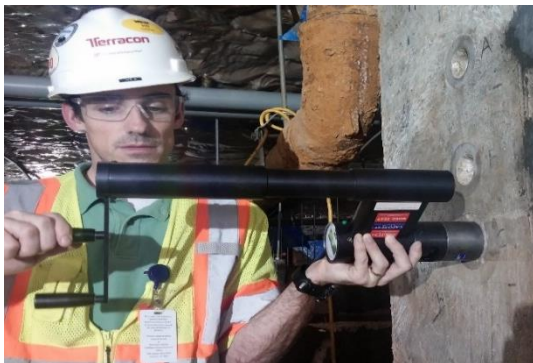
Columns, Houston  
Strength before further loading

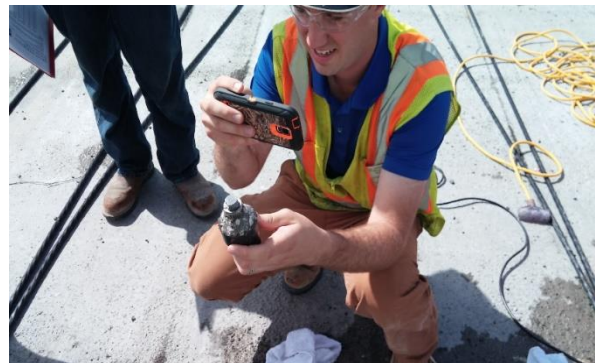
Bridge joints, Kentucky  
Strength before loading

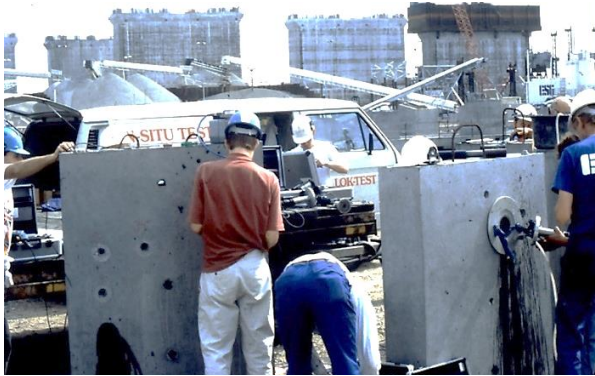
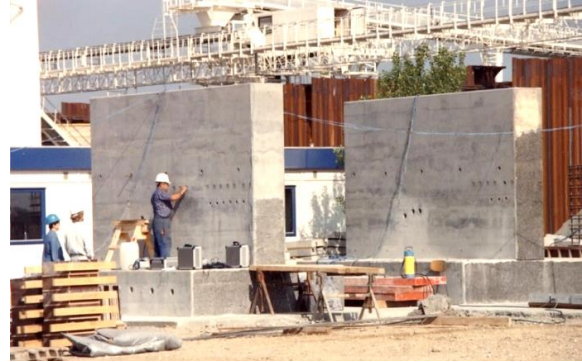
Great Belt Link, Denmark  
 LOK-TEST and CAPO-TEST training for production control with emphasis on the cover layer

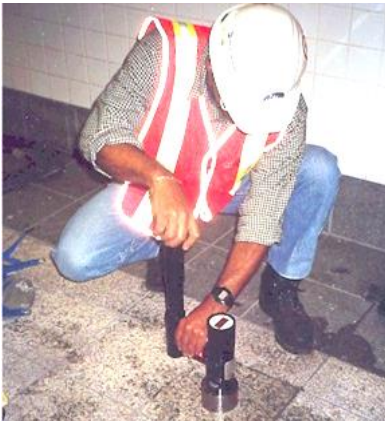
New York Metro  
 Tile adhesion

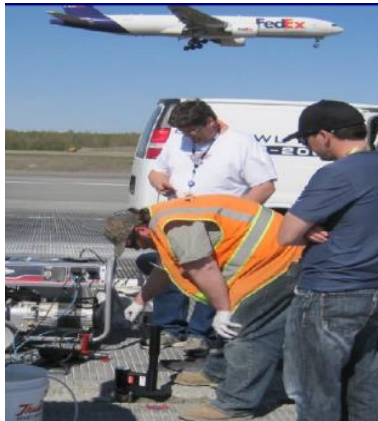
Joint testing at Anchorage Airport runway, Alaska  
 Testing of substrate before applying the joint overlay

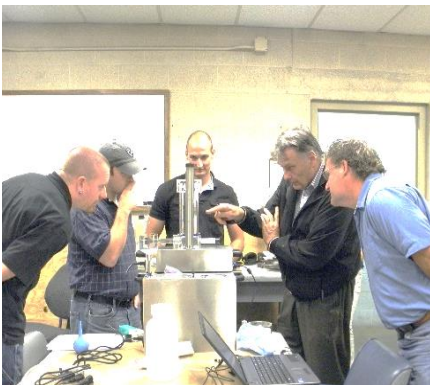
AVA-3000, FHWA, Topeka, Kansas, USA

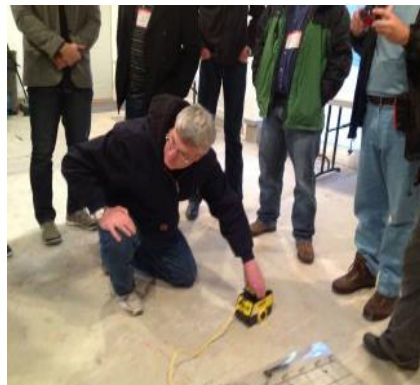
GPR, Germann Instruments, Denmark
